Windsor Building-Town Shores of Gulfport
3210 59TH ST S,
Gulfport, Florida 33707

***Limited Condition Survey Report of:
Common Area Carport***

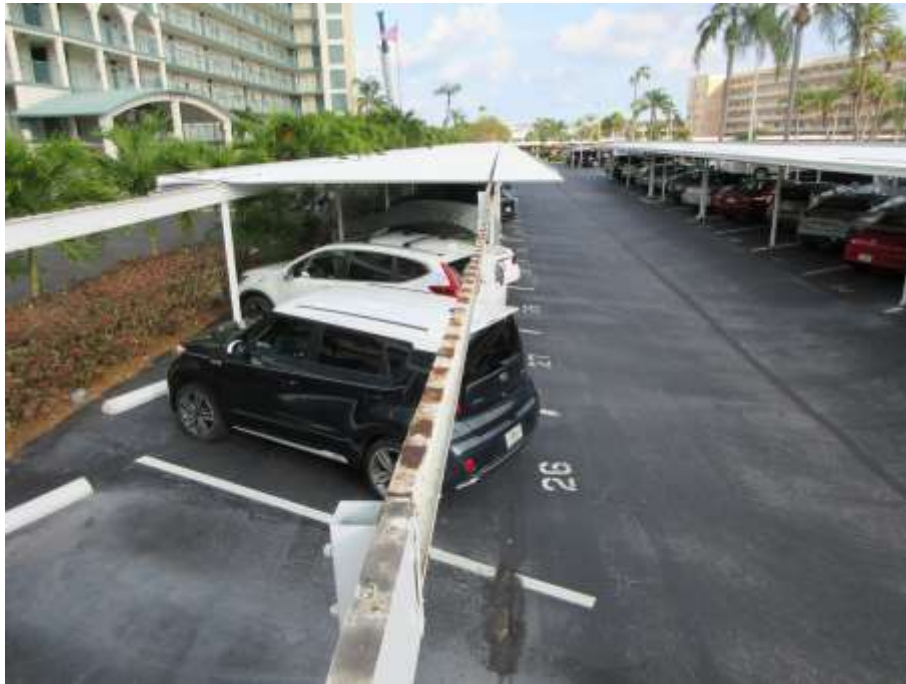
Project Consultant:
Karins Engineering
Firm Registration Number 8371

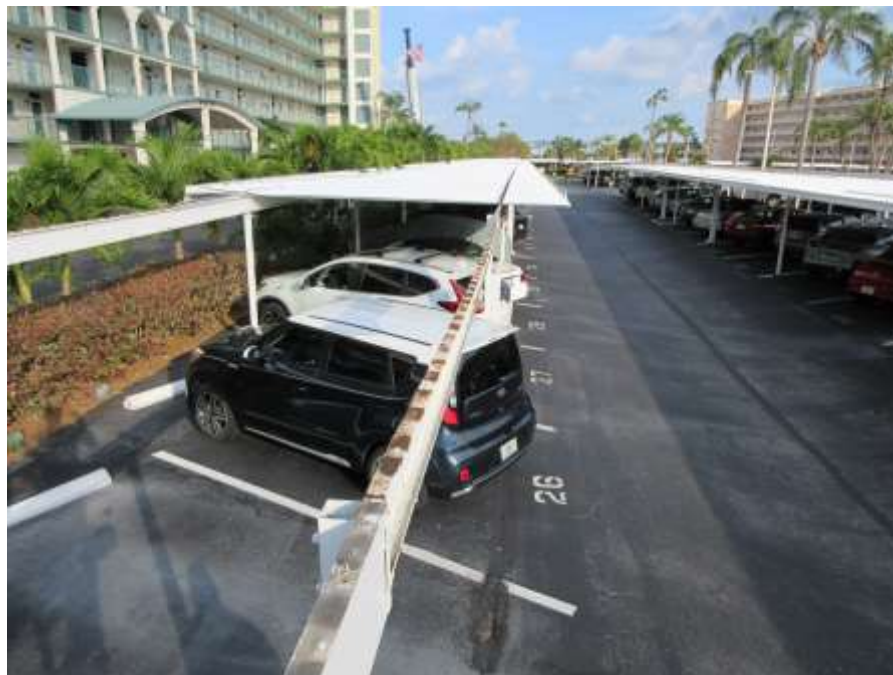
Photo No. 1– Missing/damaged section of the carport from previous hurricane season.

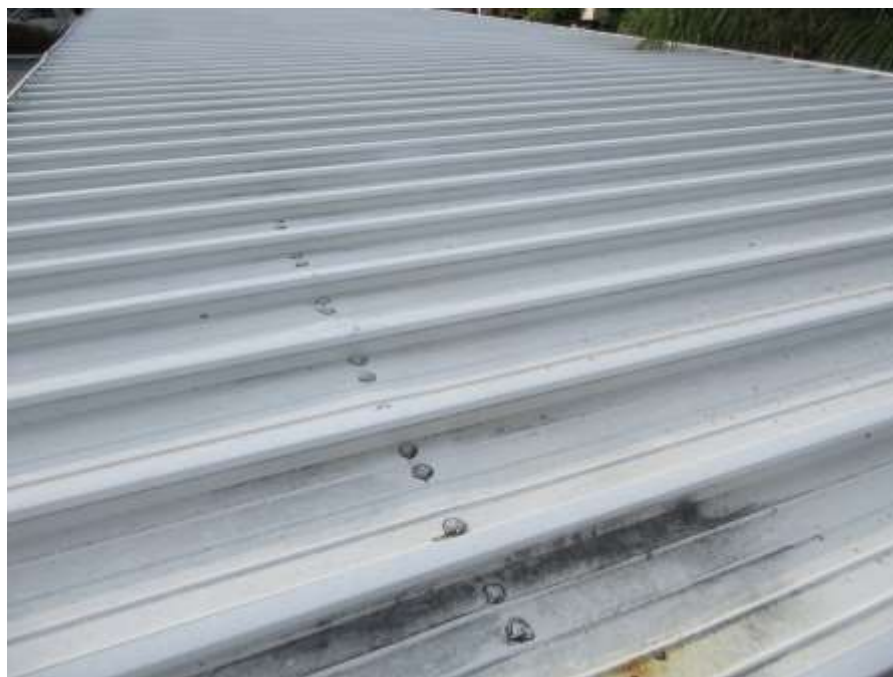
Photo No. 2 – Top view of carport. Evidence of stains from water ponding and bad sealant around fasteners.

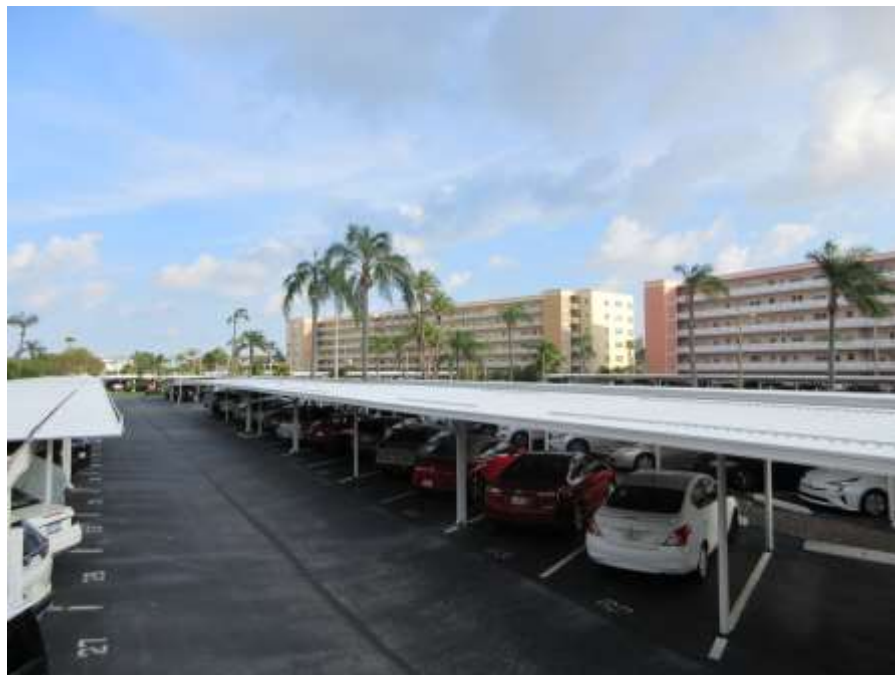
Photo No. 3 – View of 2 out 3 canopies.

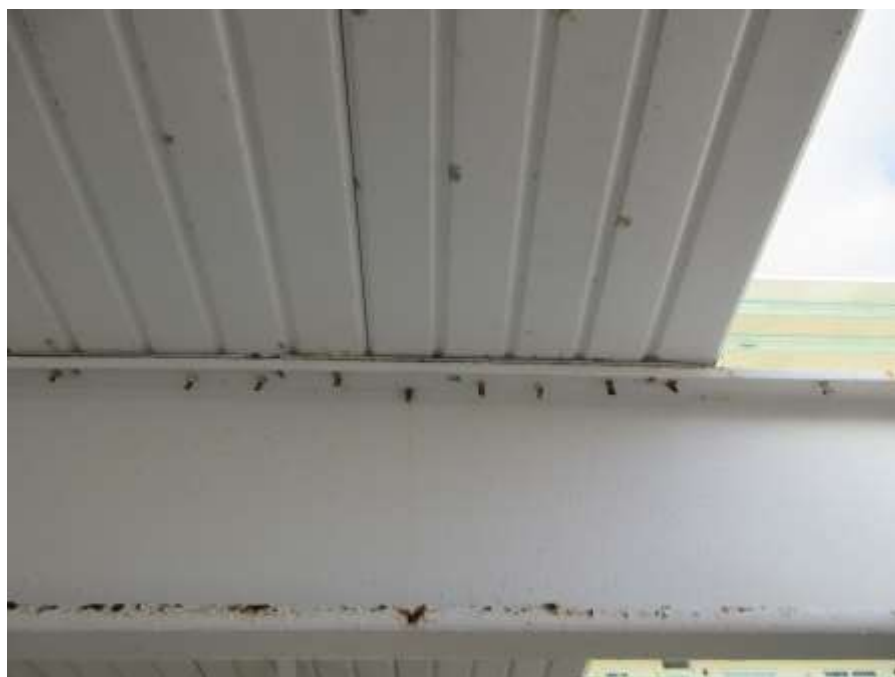
Photo No. 4 – Metal sheet improperly attached to
Corroded beam with rusted fasteners.

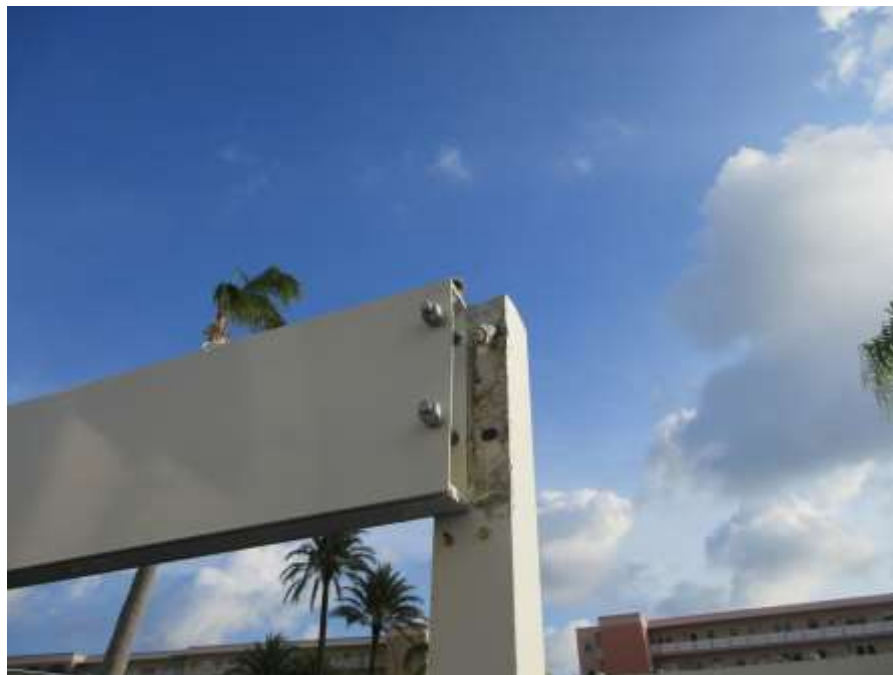
Photo No. 5 – Remaining structure elements showing improper bolt spacing

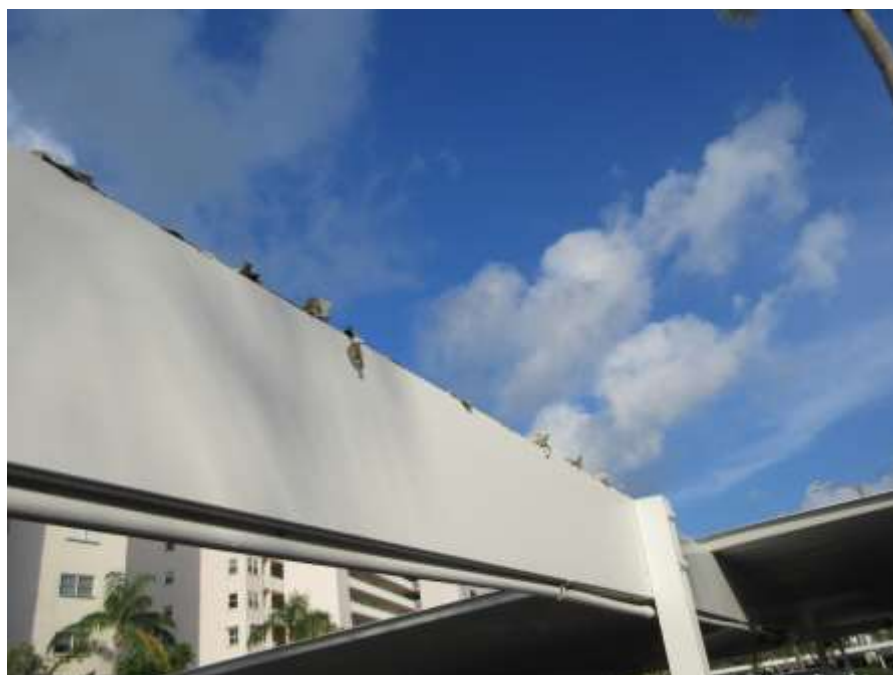
Photo No. 6 – Evidence of panel shear failure

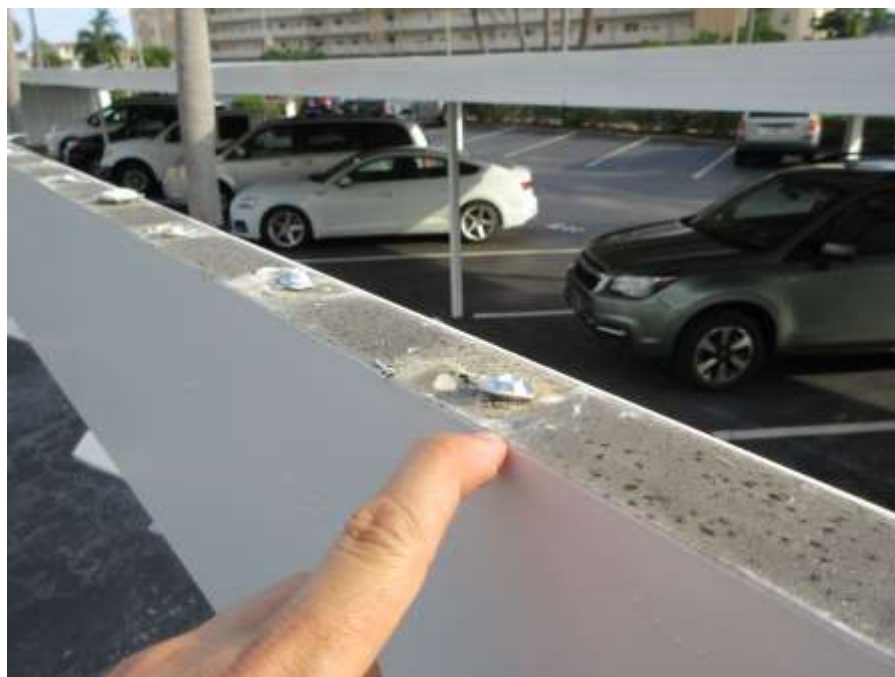
Photo No. 7 – Evidence of panel shear failure

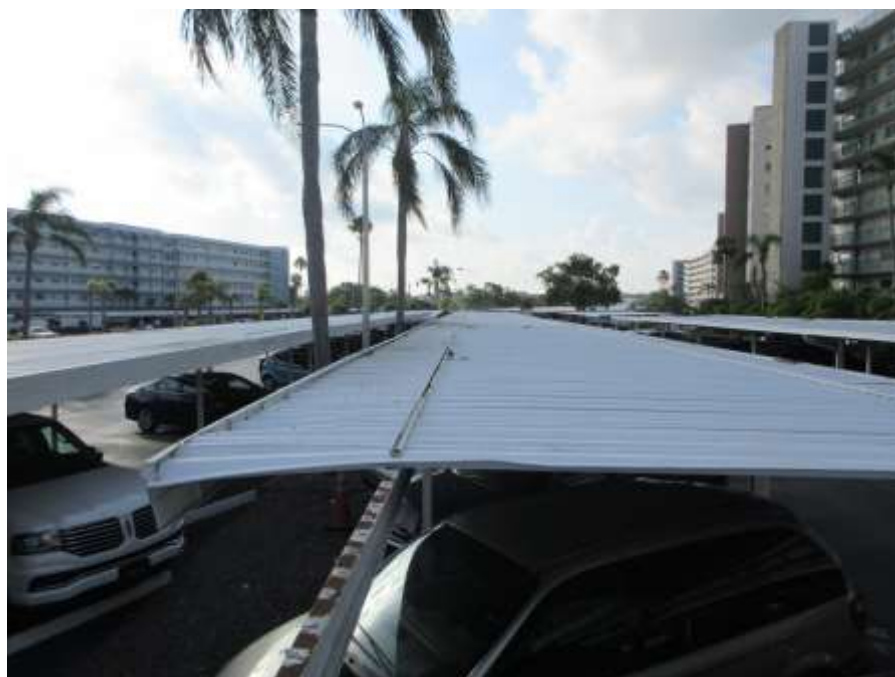
Photo No. 8 – Damages from previous major rain event

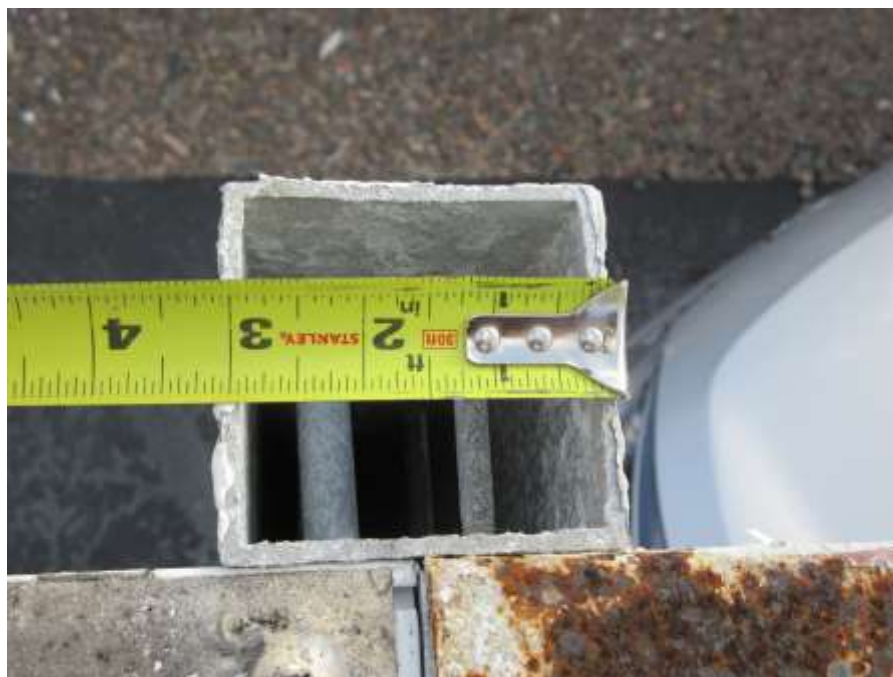
Photo No. 9 – 3” square tube columns built in the concrete foundation pads

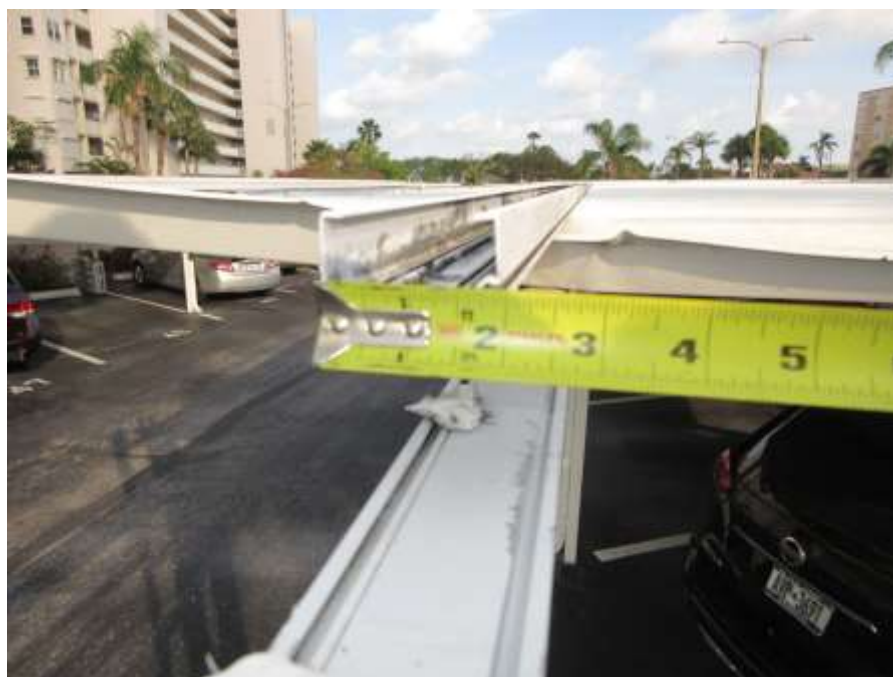
Photo No. 10 – Typical 2”x1” Screen Channels

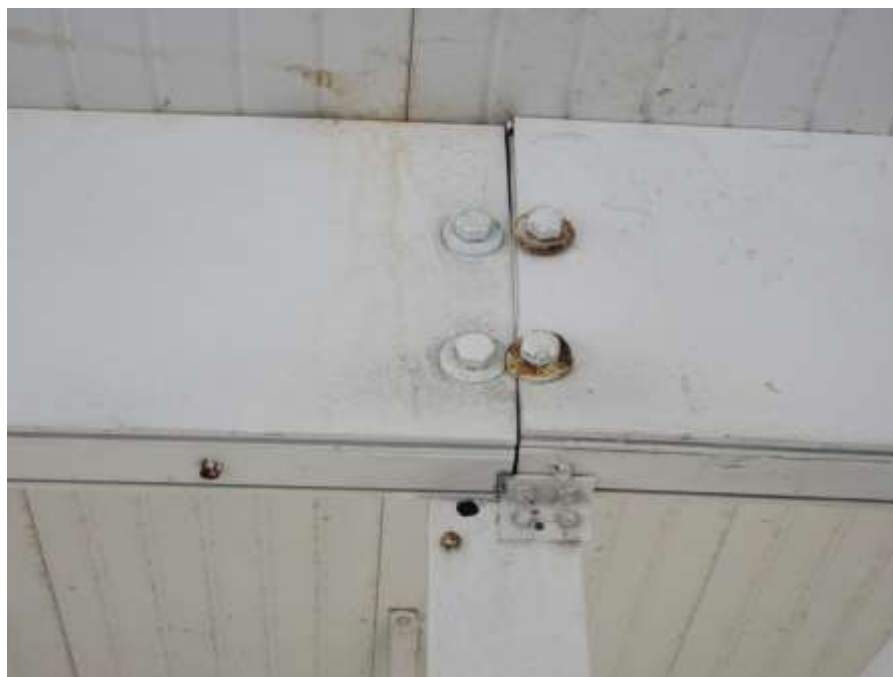
Photo No. 15 – Connection with improper bolt spacing and rust (TYP.)

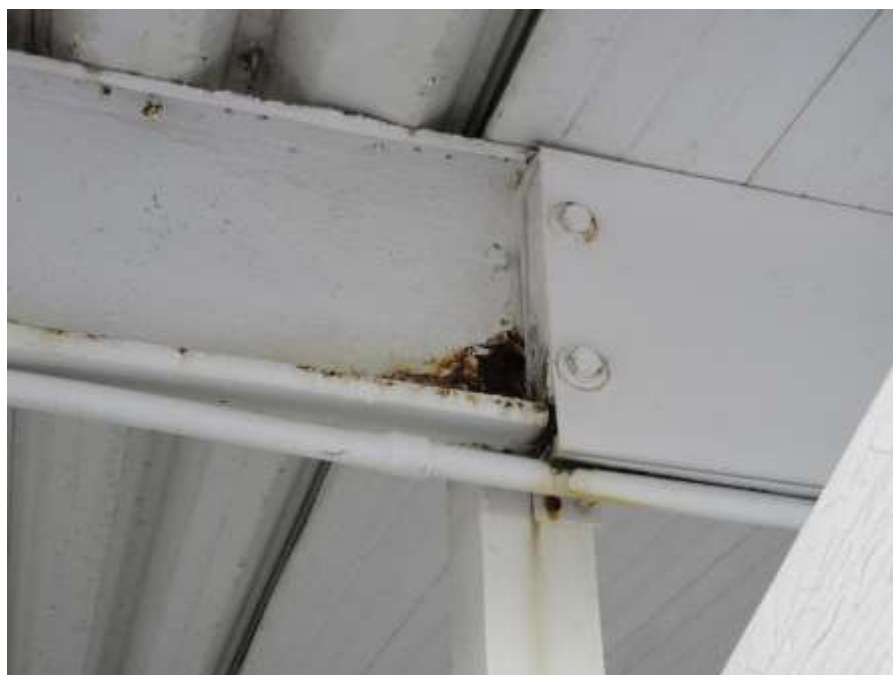
Photo No. 16 – Improper steel-to-aluminum members load connections. I-Beam has loss of section due to rust.

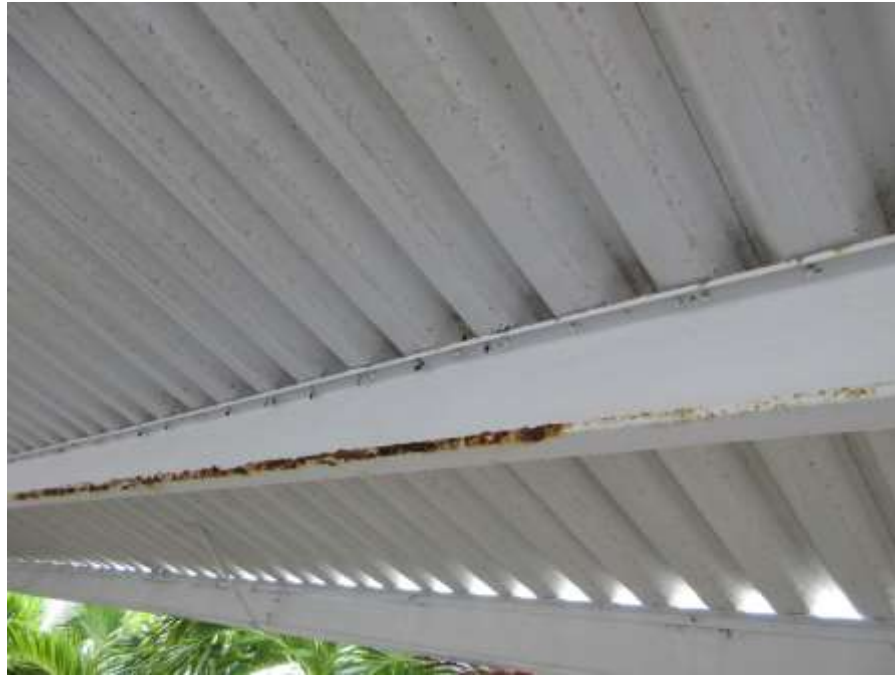
Photo No. 17 – Rusted beam supporting the roof framing of the carport.

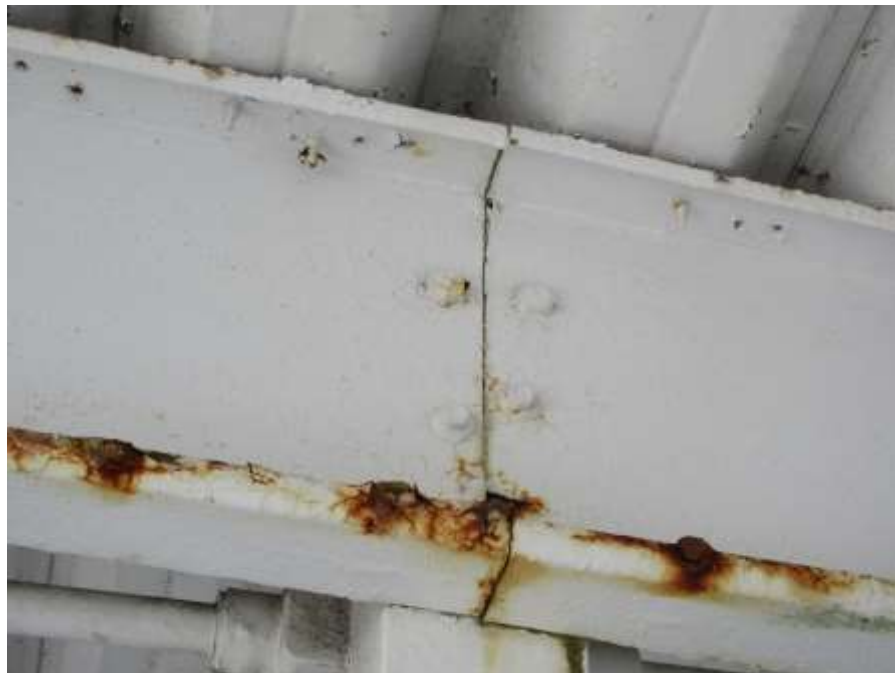
Photo No. 18 – Rusted steel section and connection with improper bolt spacing

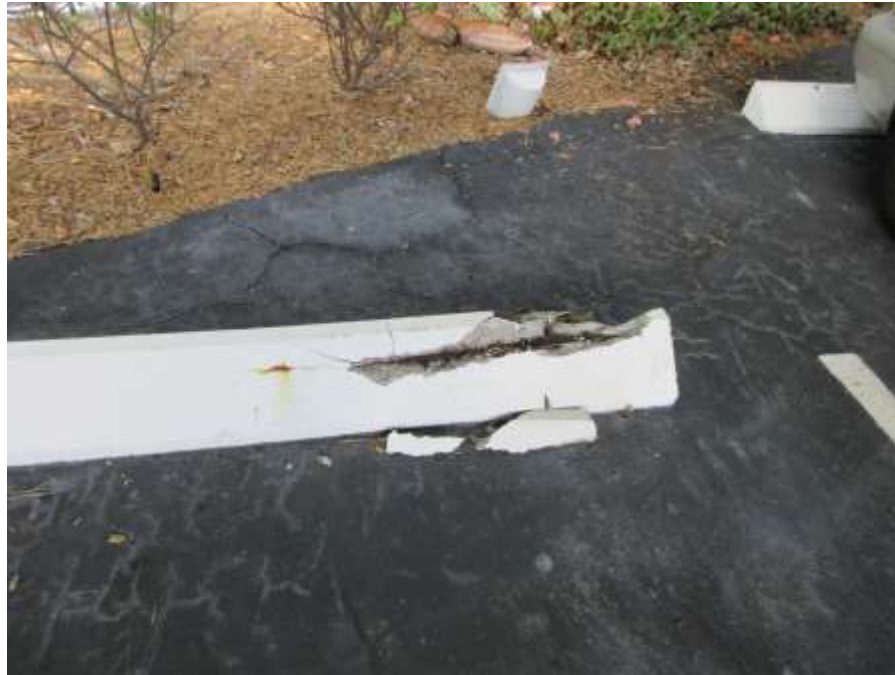
Photo No. 19 – Damaged parking lot blocks (TYP.)

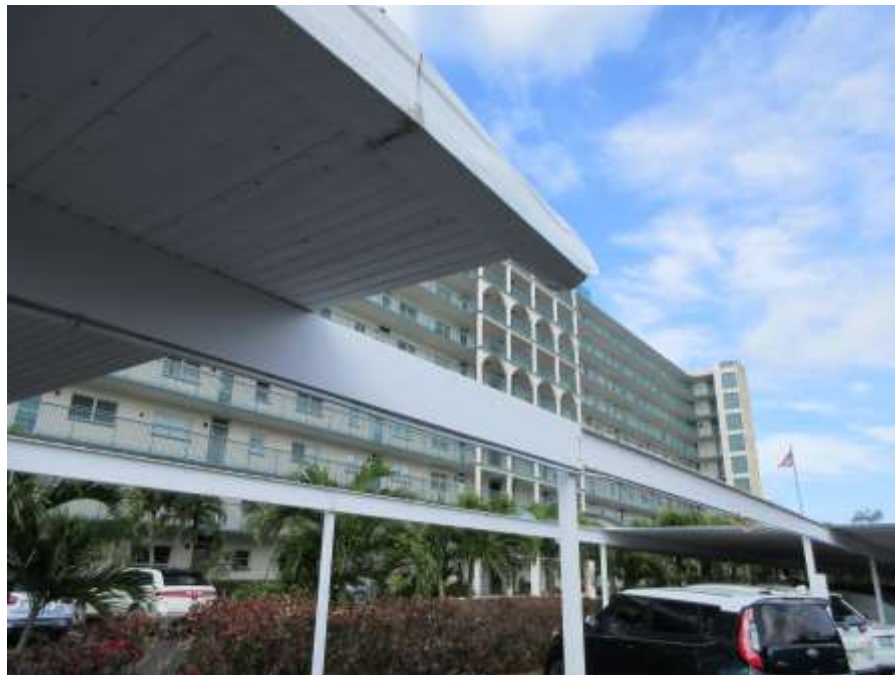
Photo No. 20– Connection of square aluminum section of beam to steel I-beam.

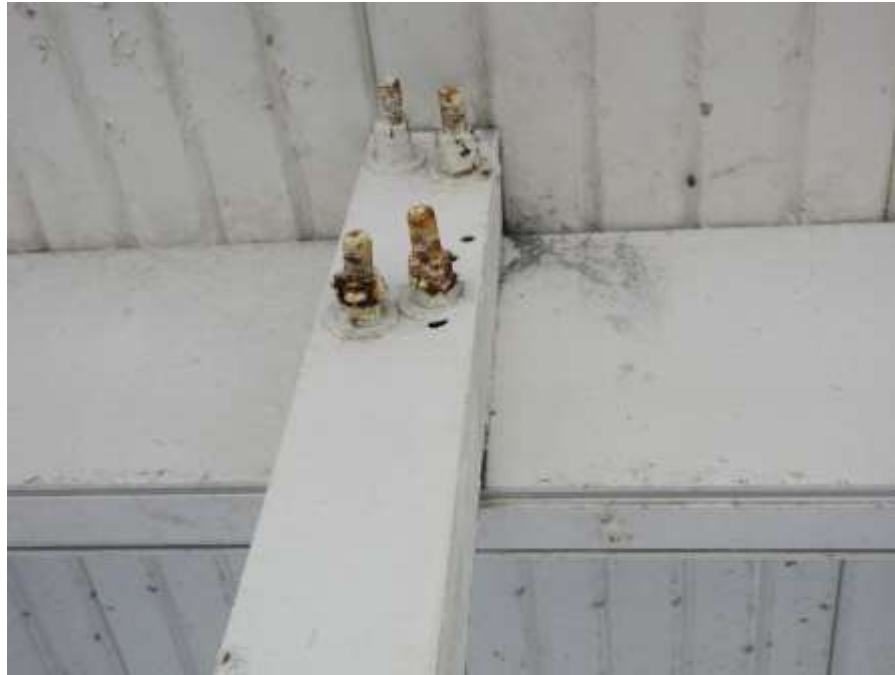
Photo No. 21 – Rusted bolts and inappropriate bolt spacing at connections

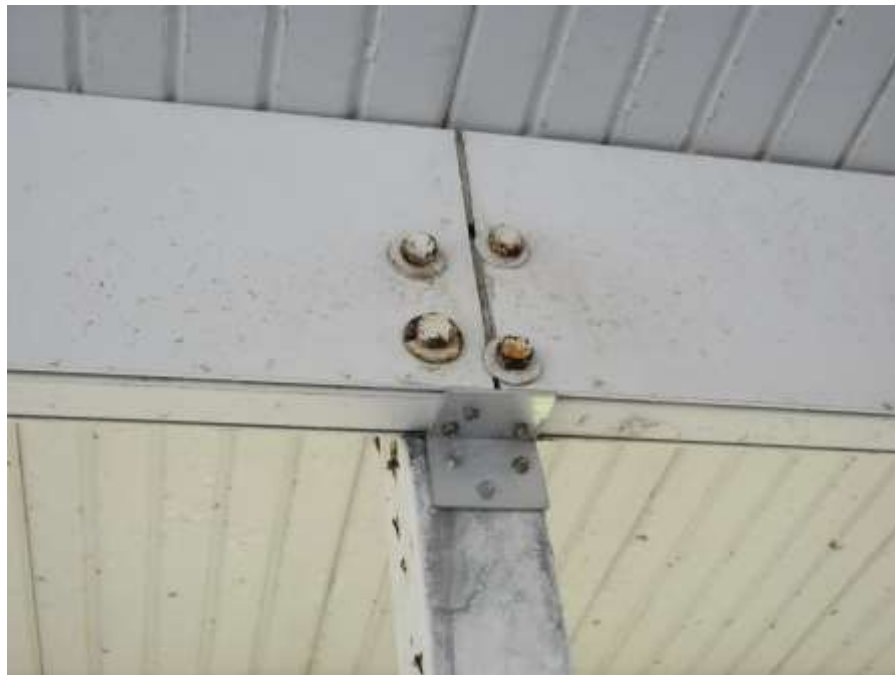
Photo No. 22 – Rusted bolts and inappropriate bolt spacing.

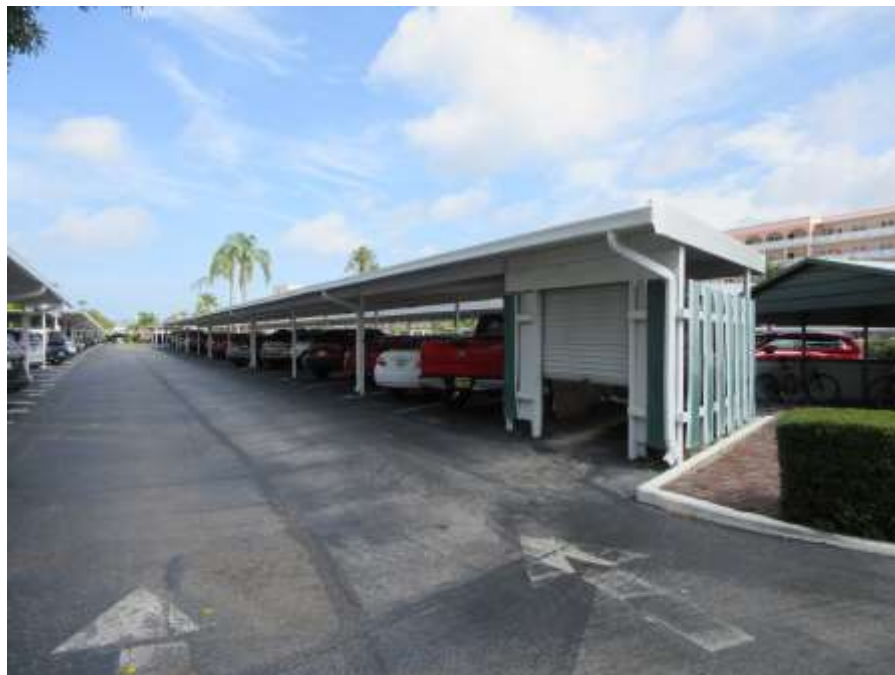
Photo No. 23 – View of small storage area under carports for trash cans and bike racks.

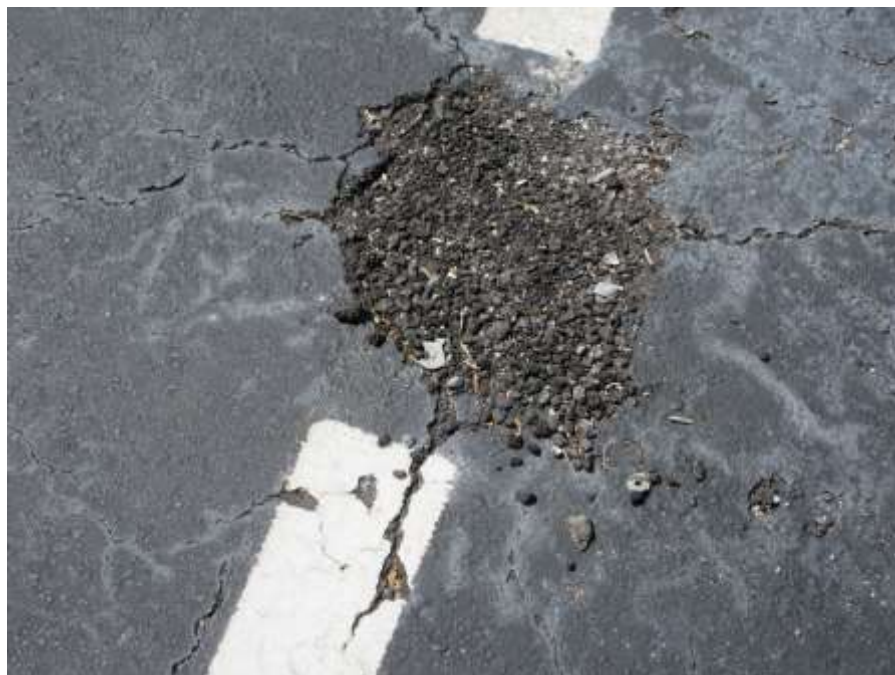
Photo No. 24 – Column at this location has been ripped off during previous hurricanes. Foundations could not be observed.

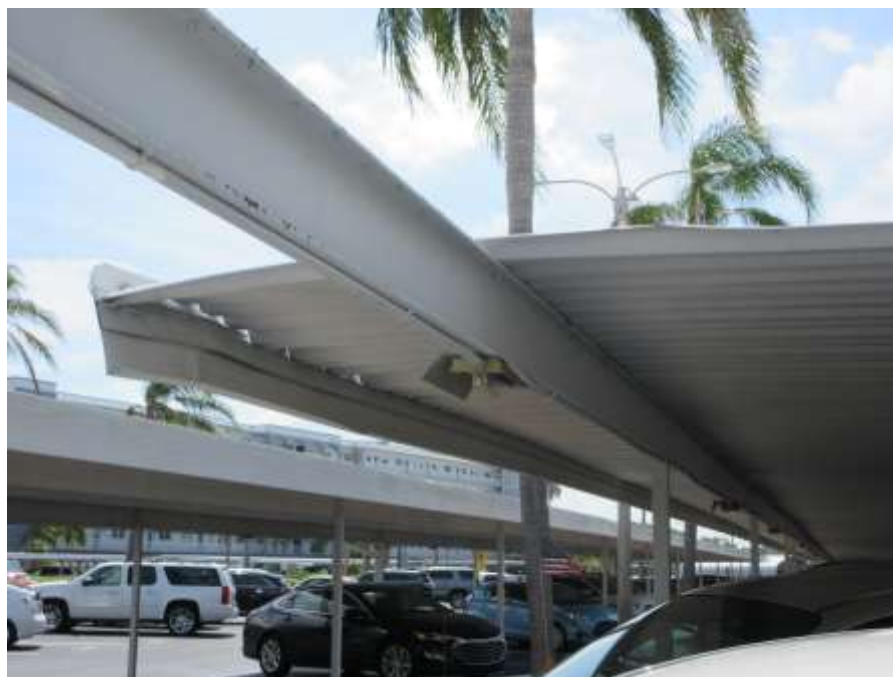
Photo No. 25 – Electrical conduits feeding the outdoor lightning devices.

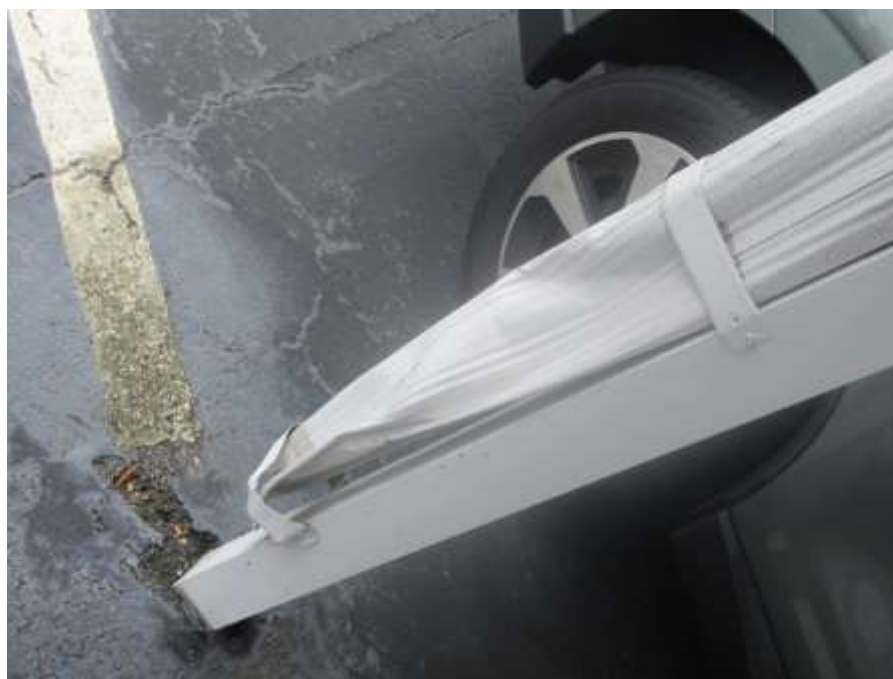
Photo No. 28 – Damaged downspouts showing obstructions in the roof drainage system. New gutters should be placed in areas safe from car collisions.
