Groton Condominium Association, Town Shores of Gulfport # 204, Inc.

October 17, 2023 • Gulfport, FL

**STRUCTURAL INTEGRITY
RESERVE STUDY**

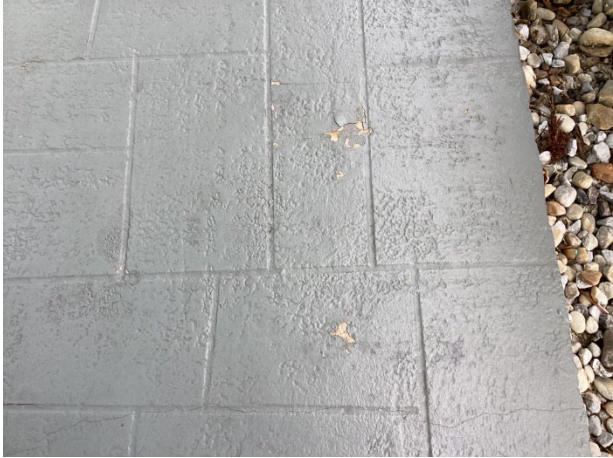
Coating deterioration at the breezeway

Useful Life: Capital repairs including a close-up visual inspection, patching of delaminated concrete, routing and filling of cracked concrete, and waterproof coating applications every 8- to 12-years.

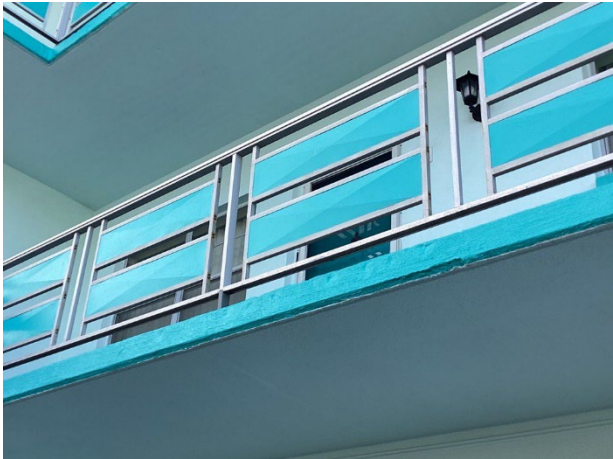
Edge spalls

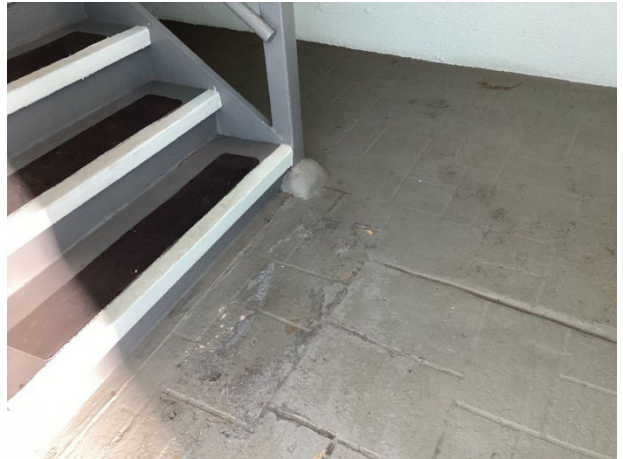
Coating deterioration at the staircase landing

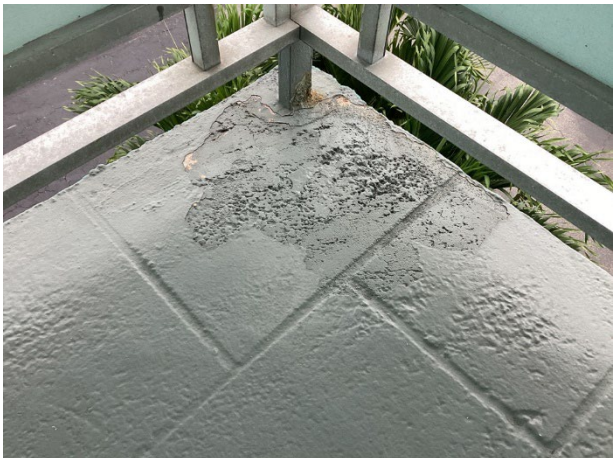
Concrete and coating deterioration at the breezeway

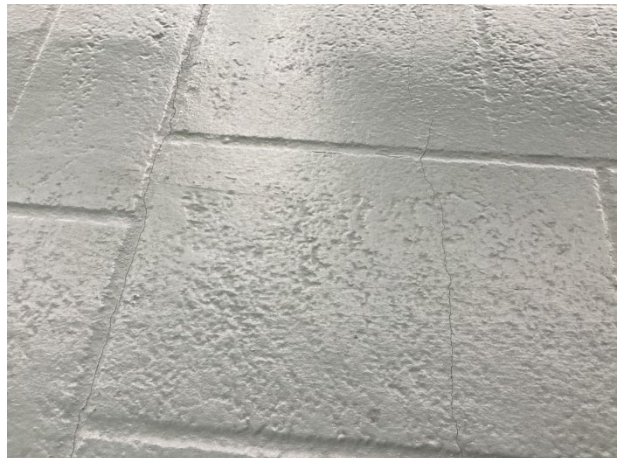
Concrete cracks at the breezeway

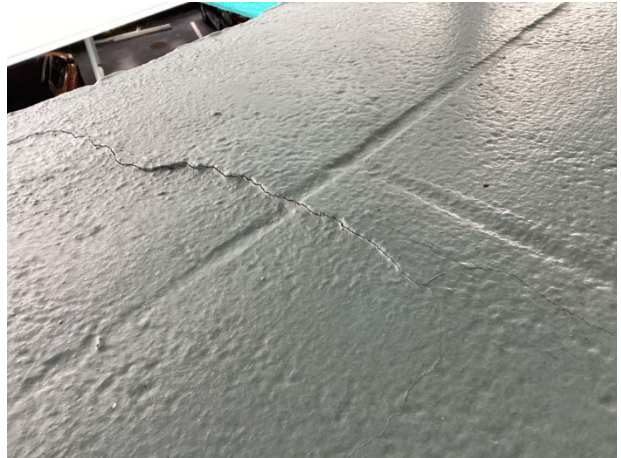
Concrete cracks at the breezeway

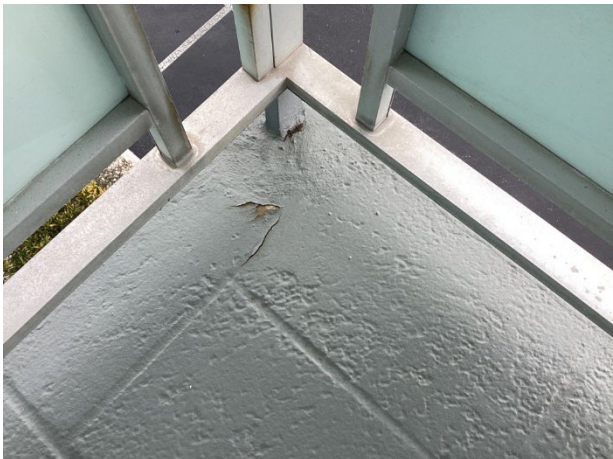
Concrete cracks and coating deterioration at the breezeway

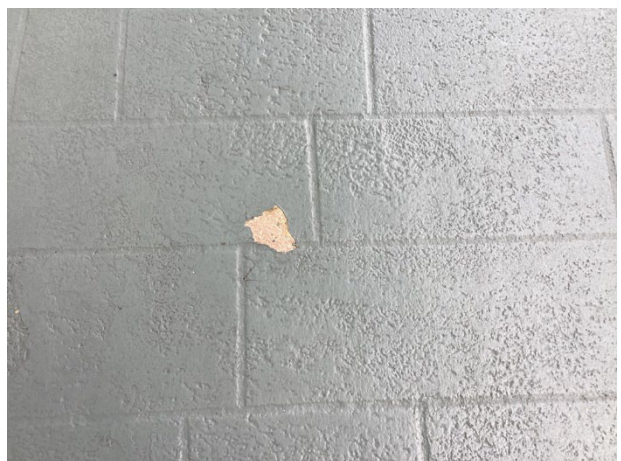
Coating deterioration at the breezeway

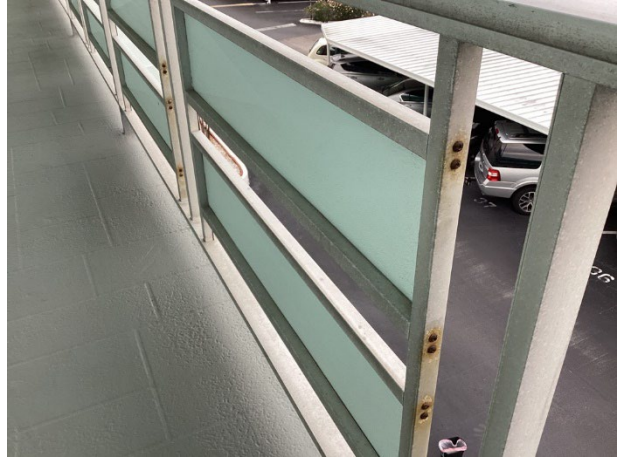
Condition: Fair overall with rust, faded finish and loose connections evident.

Rusted fasteners at the breezeway railings

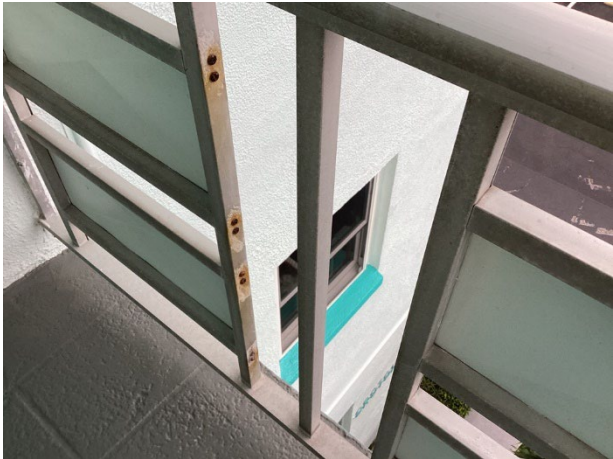
Rusted fasteners and finish fade at the breezeway railings

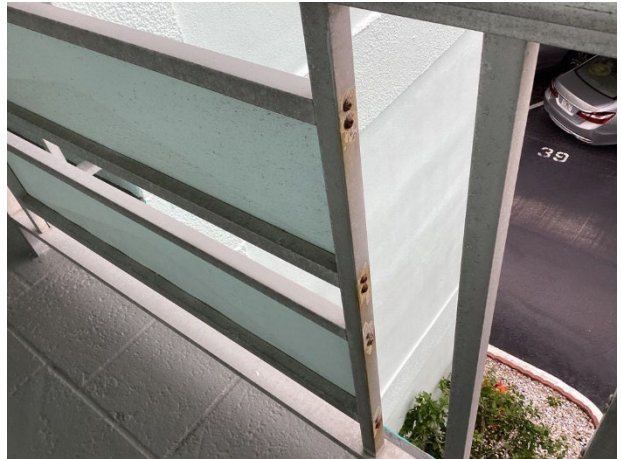
Rusted fasteners and finish fade at the breezeway railings

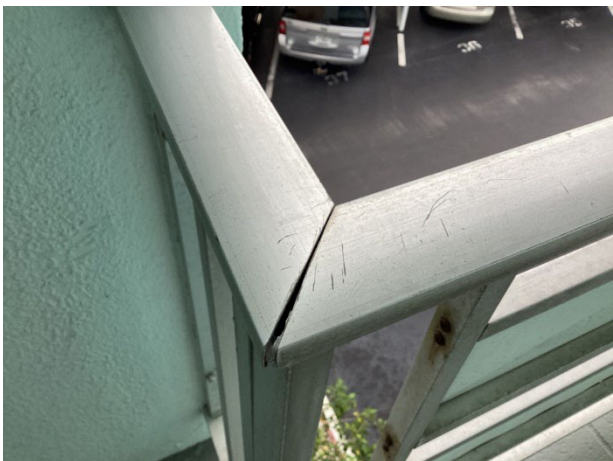
Loose connection at the breezeway railing

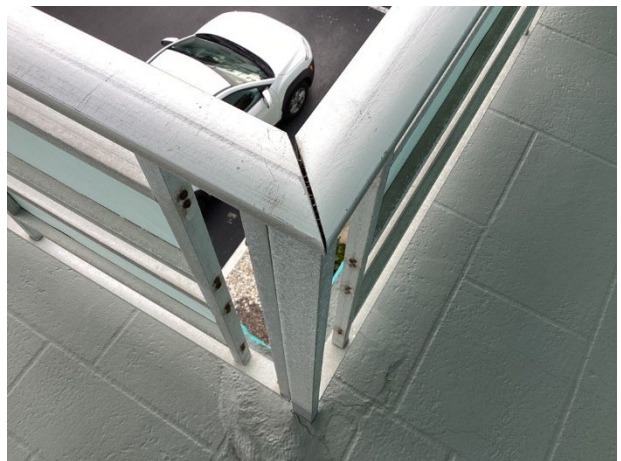
Loose connection at the breezeway railing

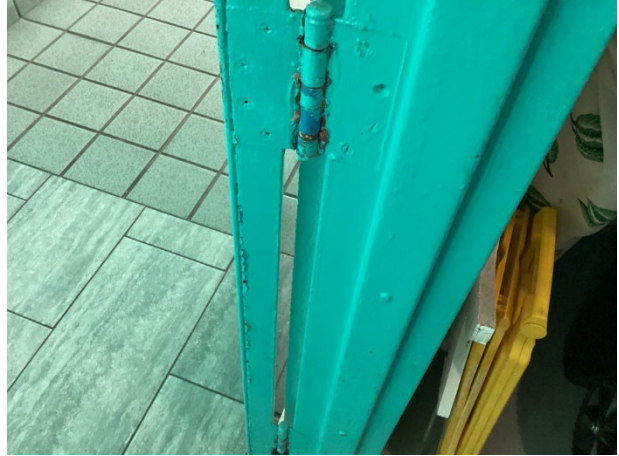
Condition: Good to fair overall with rust and peeling finishes evident.

Rust and peeled finishes at the common area door

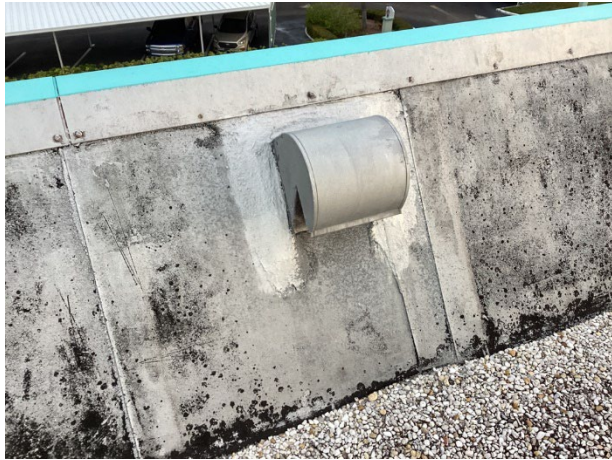
Patch repairs at the parapet walls

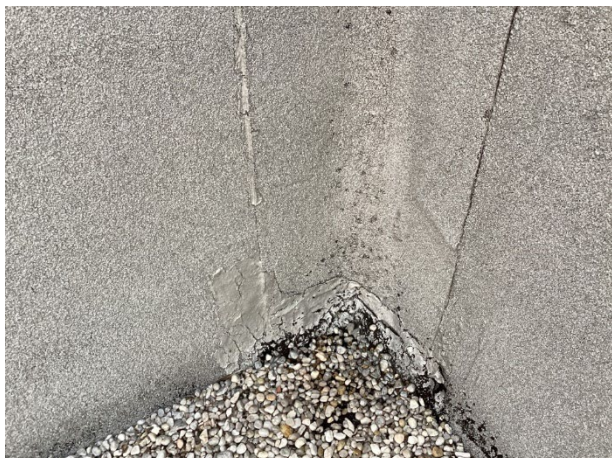
Patch repairs at the parapet walls

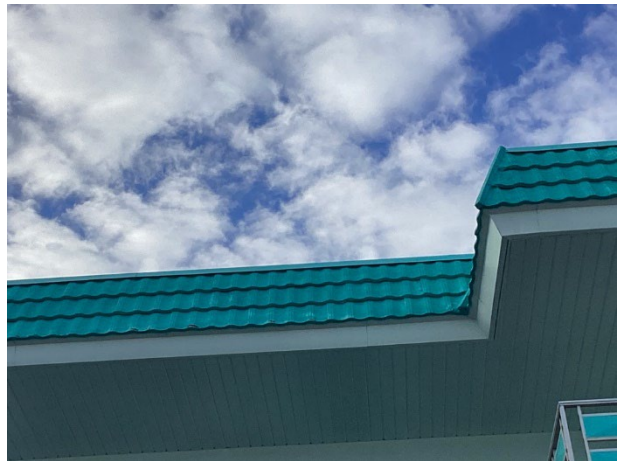
Damage at the metal mansard roof

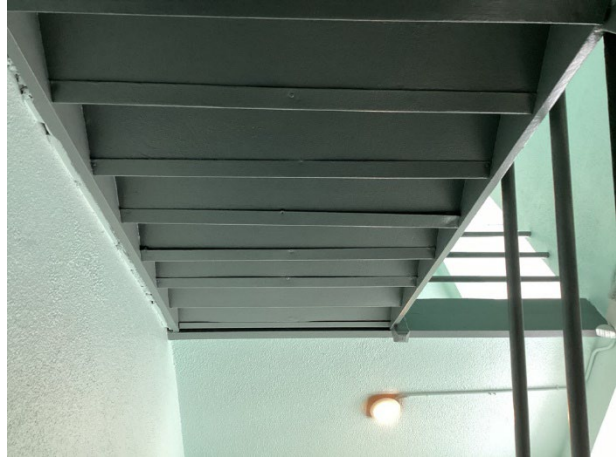
Condition: Good to fair overall with isolated damage evident.

Staircase underside with damage at the wall connection

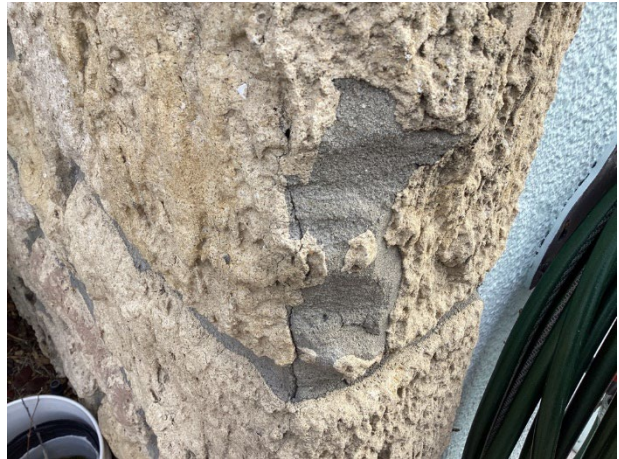
Mortar cracks

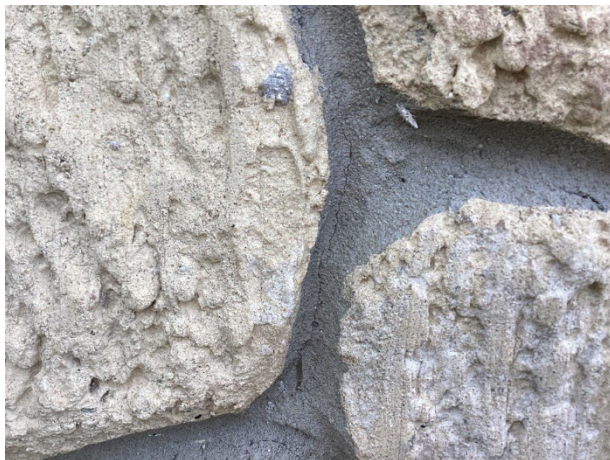
Mortar cracks

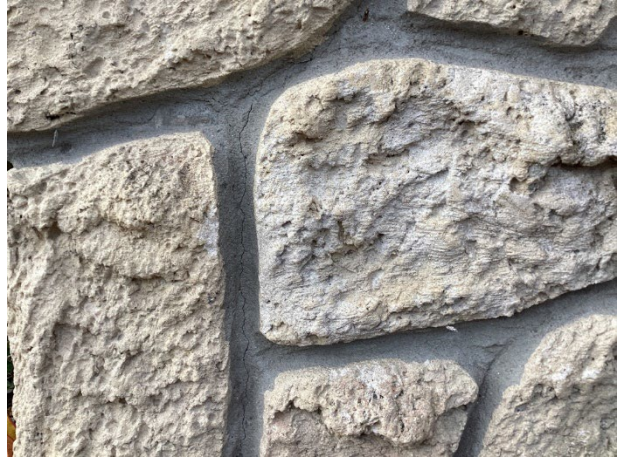
Mortar cracks

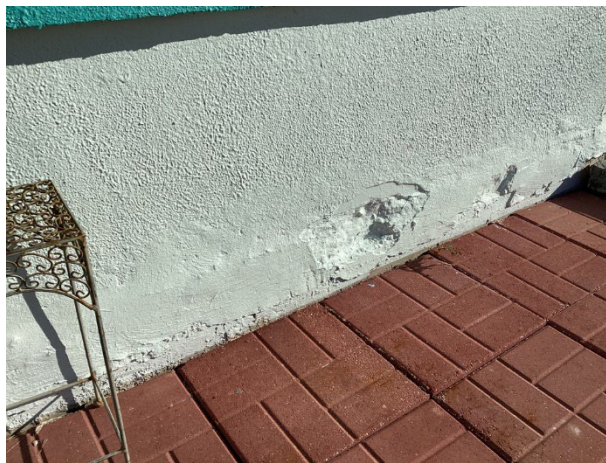
Spalls

Useful Life: We recommend inspections, repairs and paint finish applications every six- to eight-years.

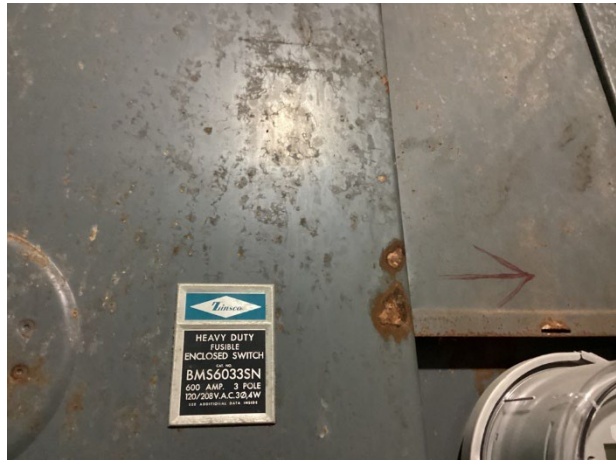
Rust at the electrical panel

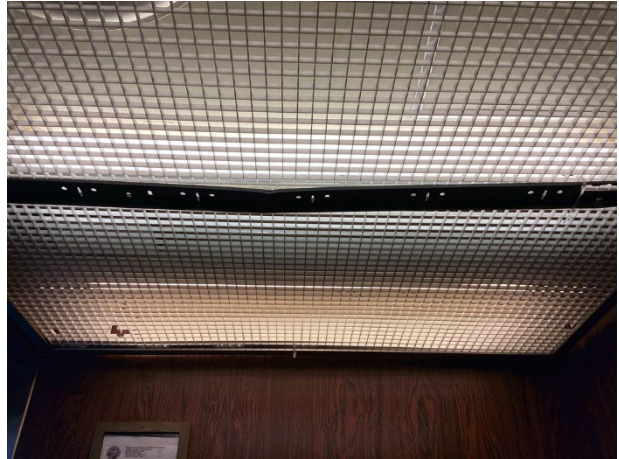
Ceiling damage

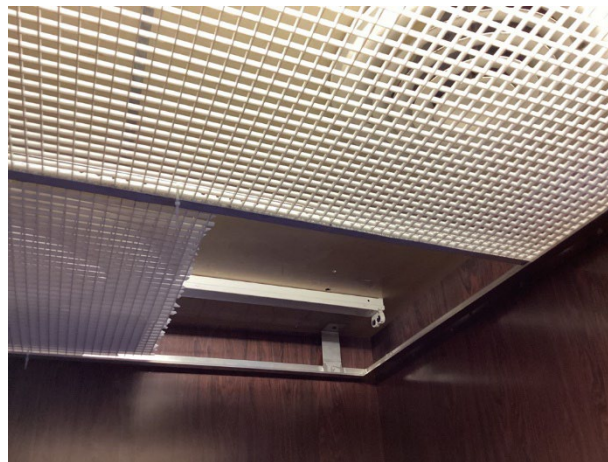
Ceiling damage

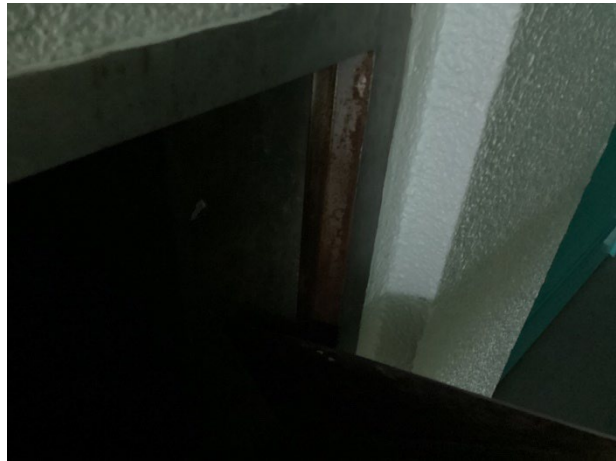
Rust evident

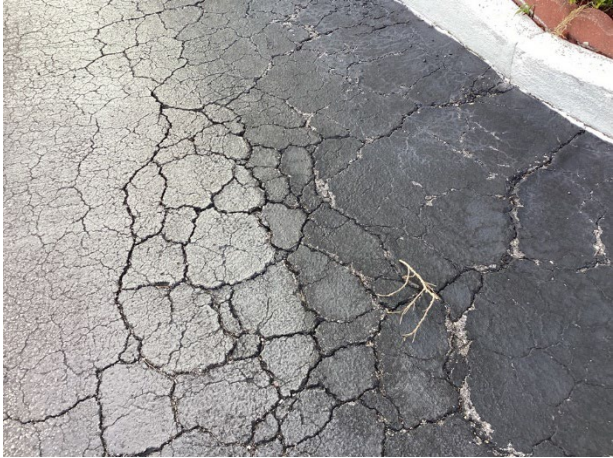
Pavement cracks

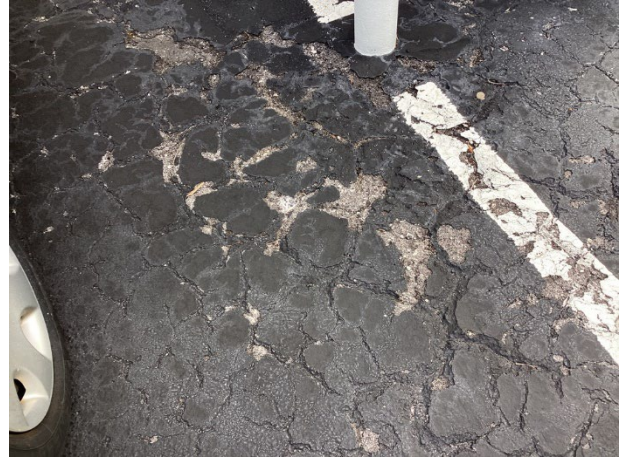
Pavement cracks and deterioration

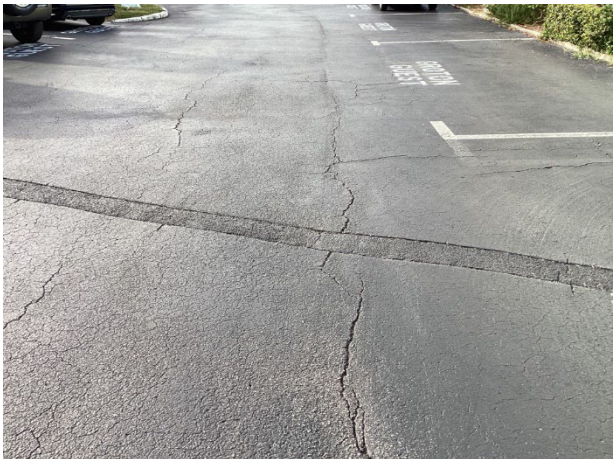
Pavement cracks

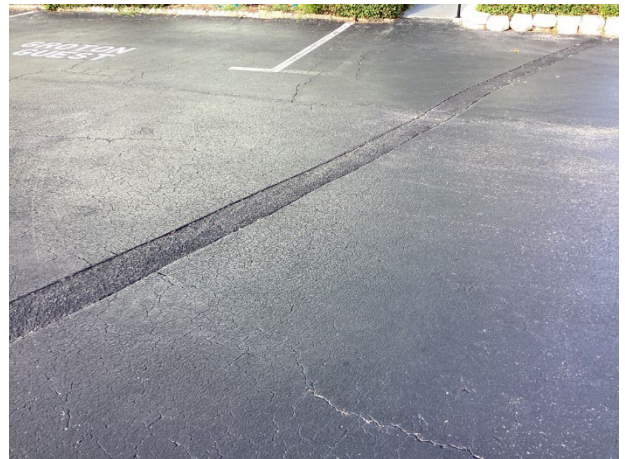
Patch repair

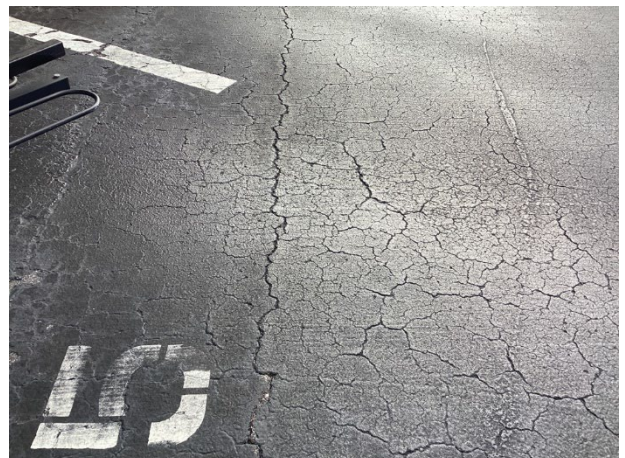
Pavement cracks

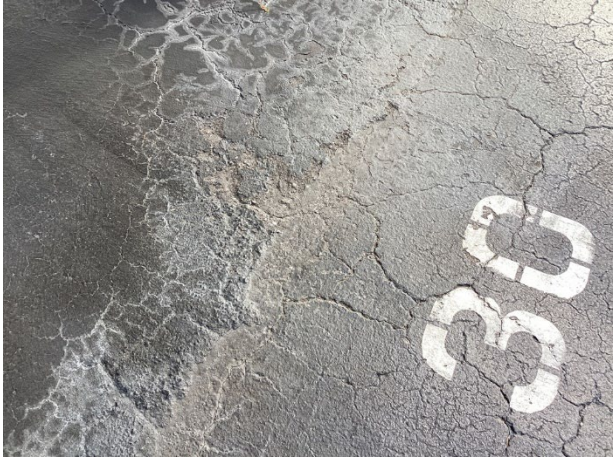
Pavement cracks and raveling

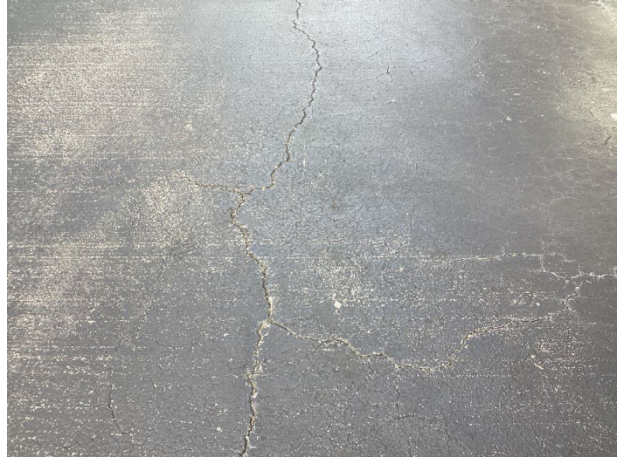
Pavement cracks

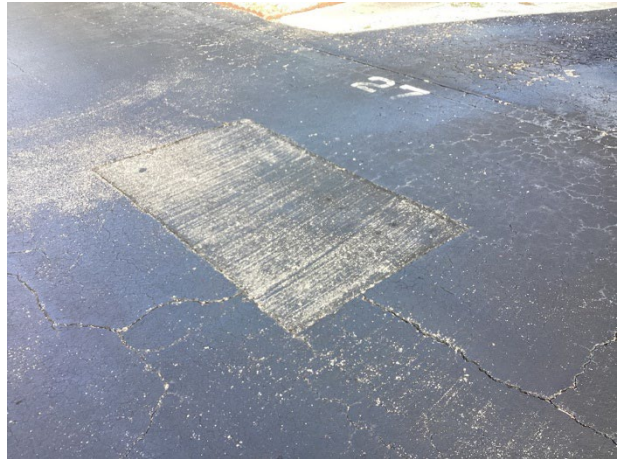
Patch repair

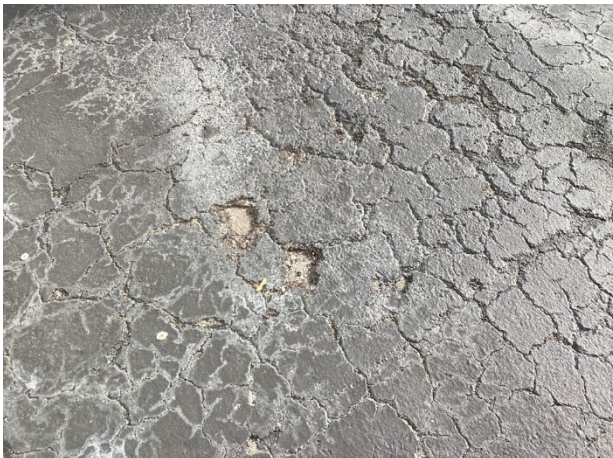
Pavement cracks and pothole formation

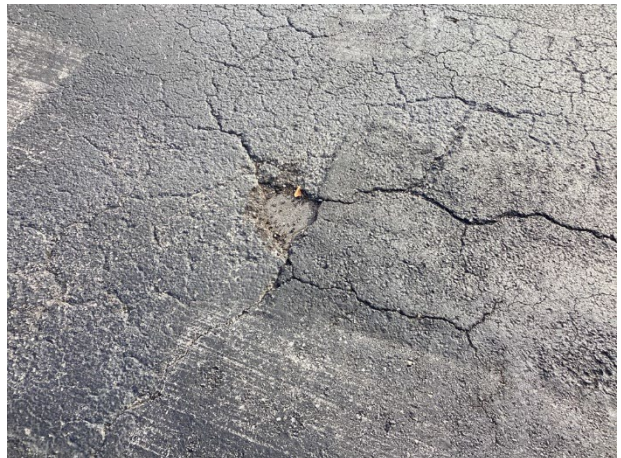
Pavement cracks and pothole formation
