Groton Condominium Association, Town Shores of Gulfport # 204, Inc.

October 17, 2023 • Gulfport, FL

**STRUCTURAL INTEGRITY
RESERVE STUDY**

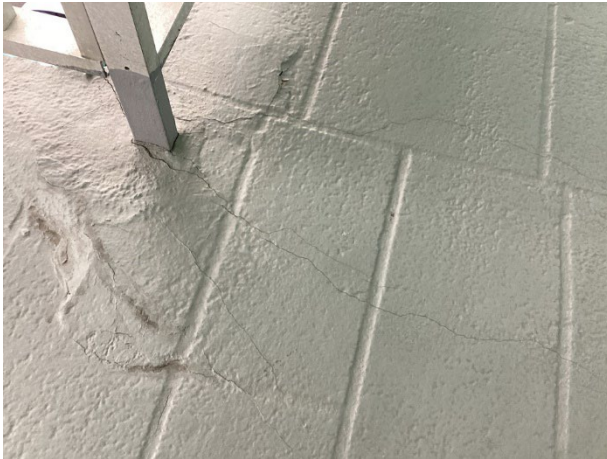
Condition: Good to fair overall with isolated cracks, deterioration and spalls evident. We note the following:

Concrete cracks at breezeway railing attachment

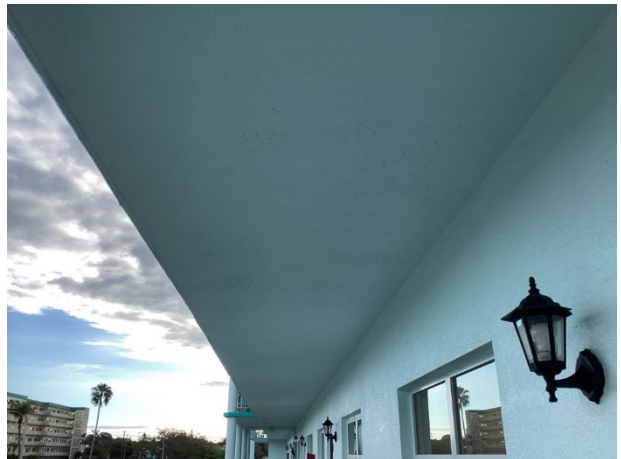
Breezeway underside overview

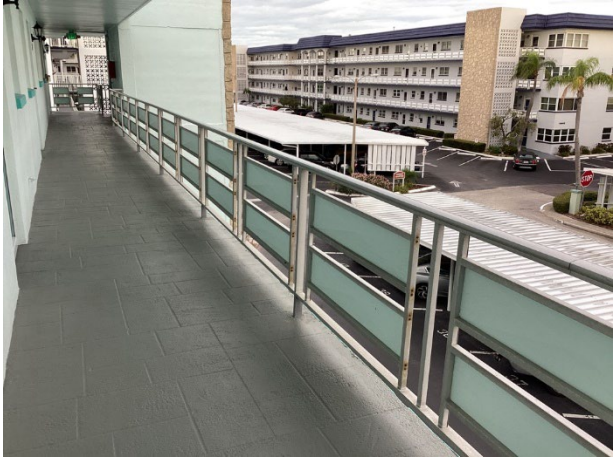
Condition: Fair overall with rust, faded finish and loose connections evident.

Metal breezeway railings

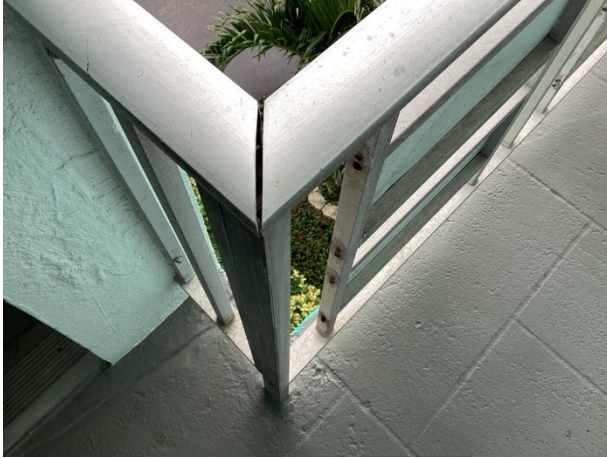
Loose connection at the breezeway railing

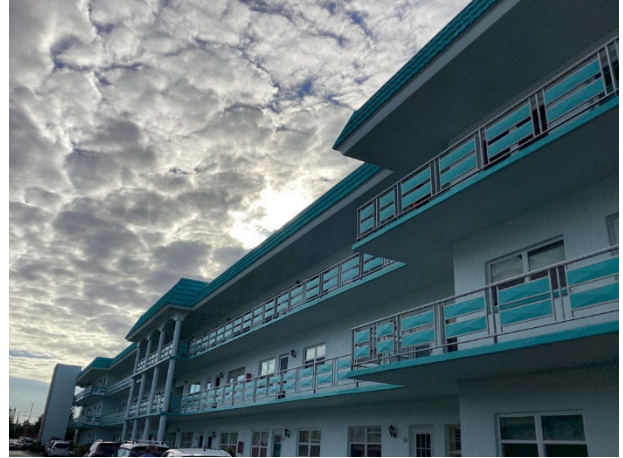
Metal breezeway railings

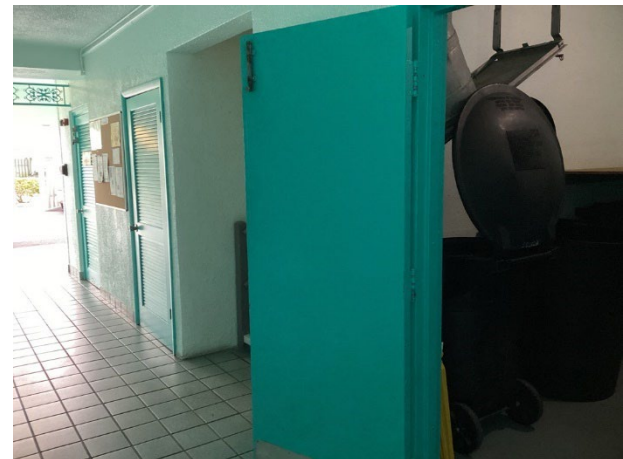
Common area doors

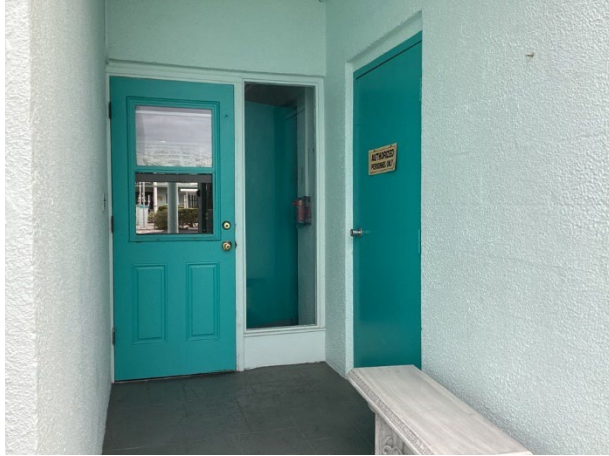
Common area doors

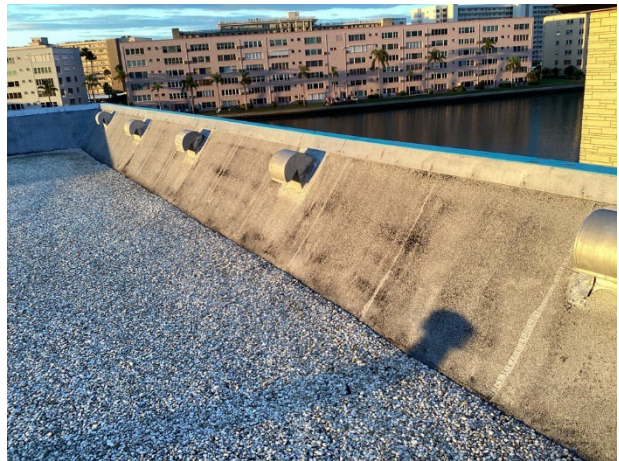
Parapet walls overview

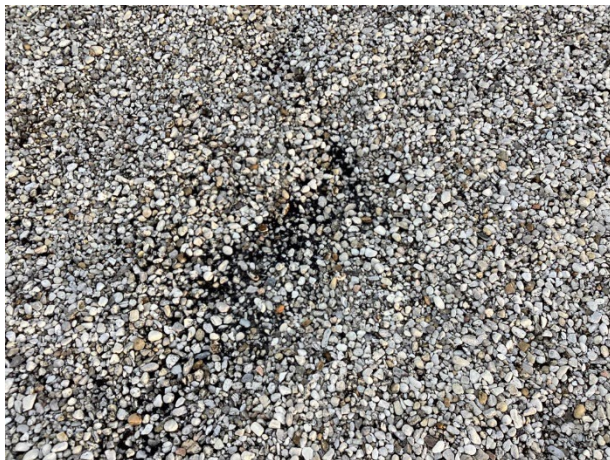
Bare spots in gravel coverage

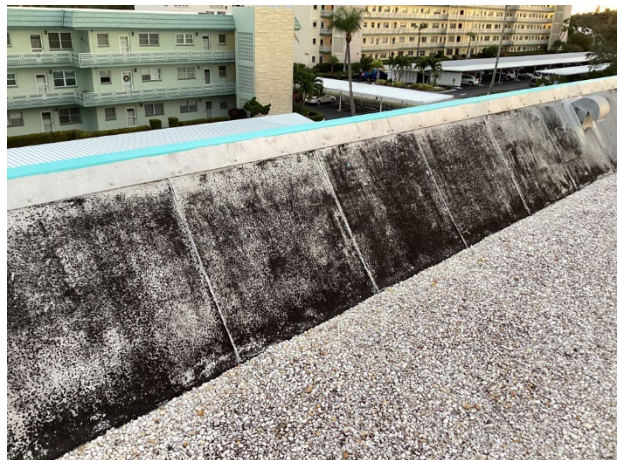
Granular loss at the parapet walls

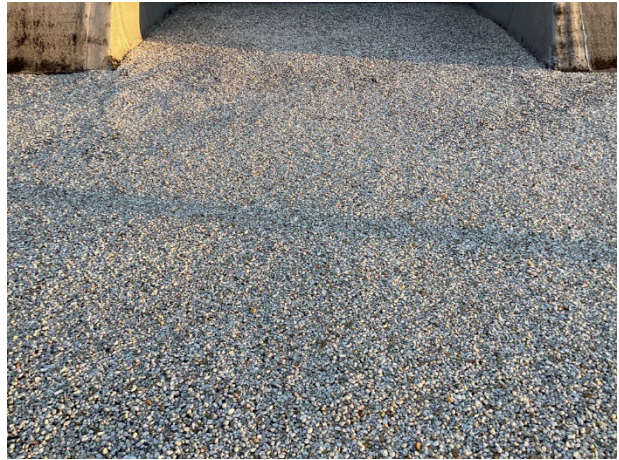
Built-up roof overview

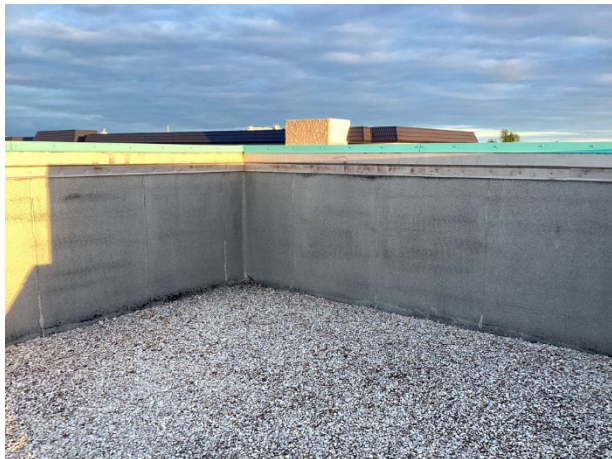
Parapet walls overview

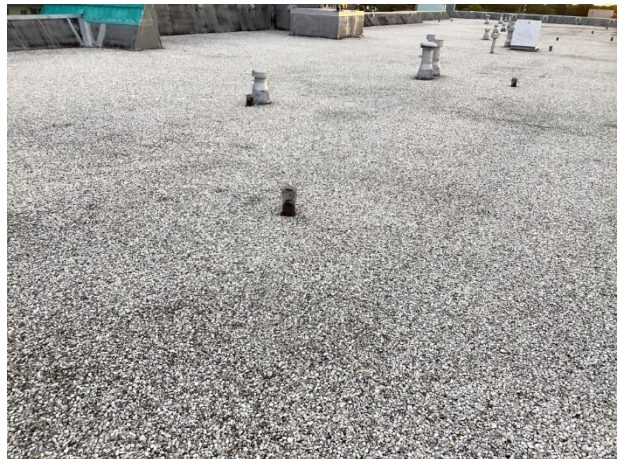
Built-up roof overview

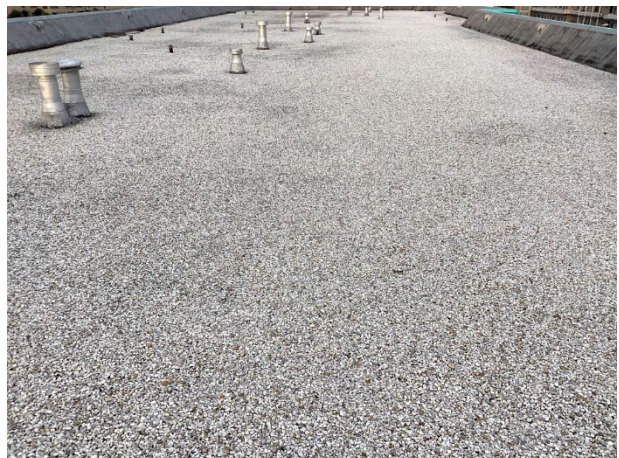
Built-up roof overview

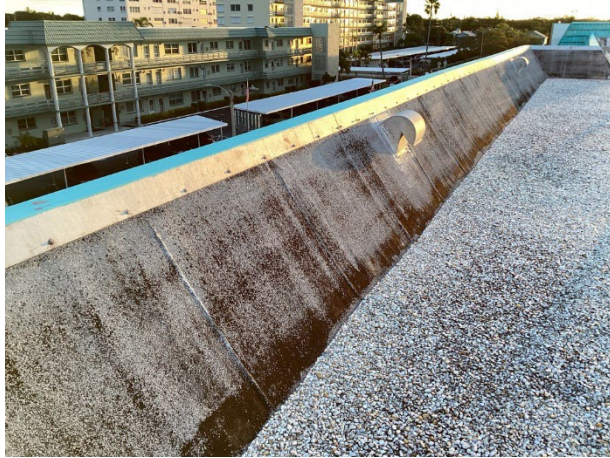
Granular loss at the parapet walls

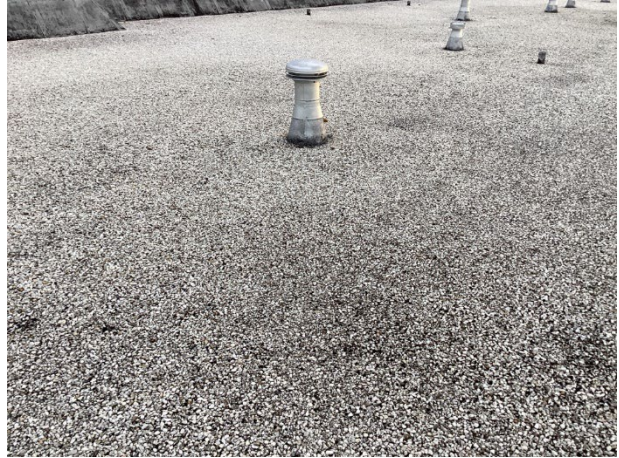
Built-up roof overview

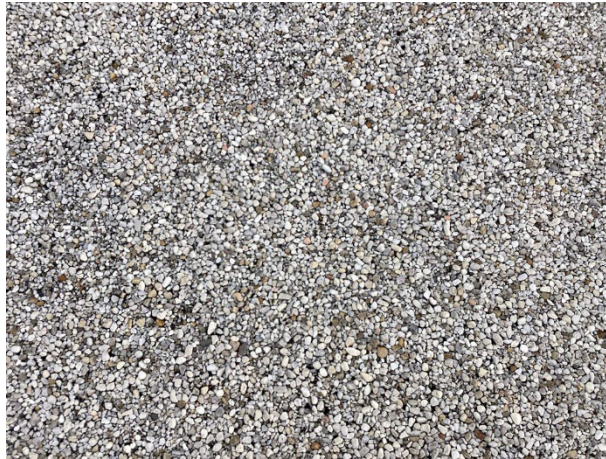
Built-up roof overview

Contractors can install a new built-up roof in one of two ways: *tear-off* or an *overlay*. An *overlay* is the application of a new roof membrane over an existing roof. This method, although initially more economical, often covers up problems with the deck, flashing and saturated insulation. The *tear-off* method of replacement includes removal of the existing roofing, flashings and insulation, and installation of a new roofing system.

The contractor should follow the manufacturer's directions and specifications upon installation of the roof. The contractor should remove the original insulation if saturated or compacted and apply a new layer of insulation per the manufacturer's instructions. The insulation should fit loosely with gaps no greater than $\frac{1}{4}$ inch. Gaps will cause failure of the membrane later. Mechanical fastening of the insulation is the best manner of installation. The contractor applies the base sheet of roofing over the insulation board.

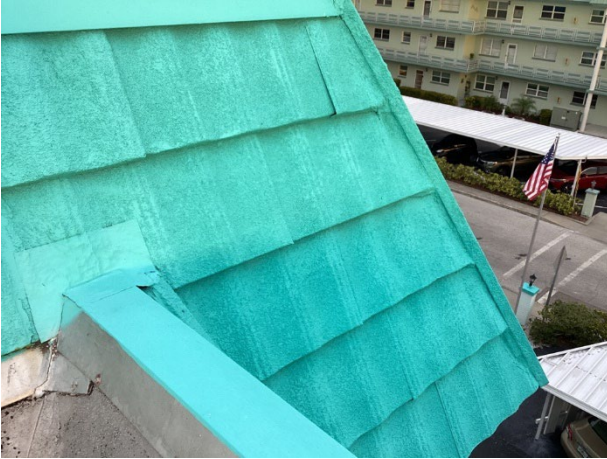
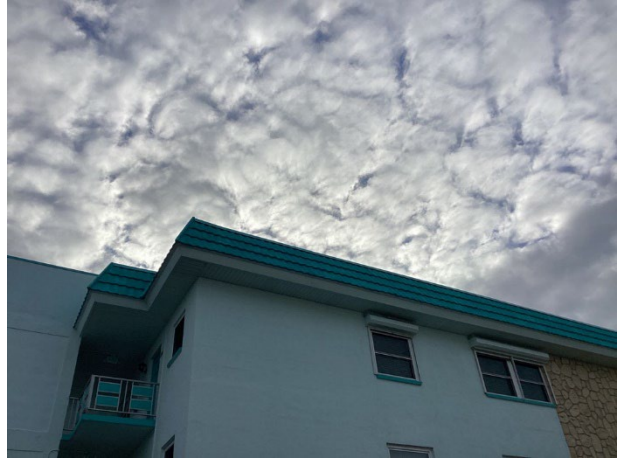
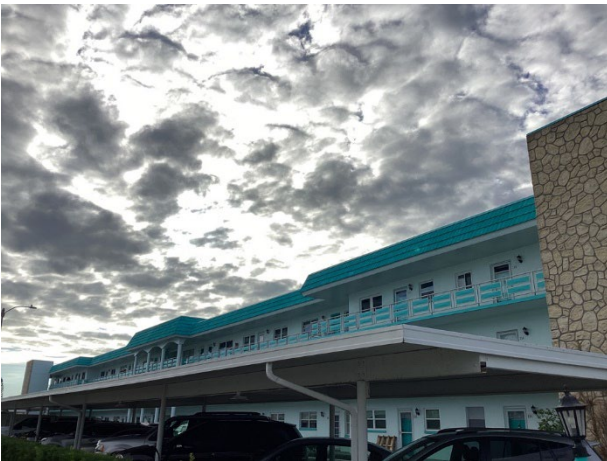
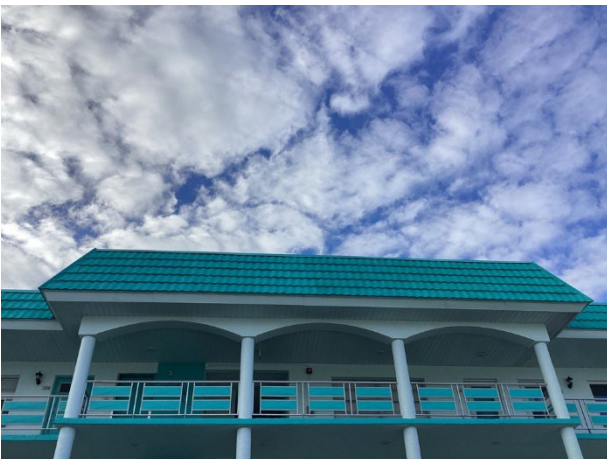
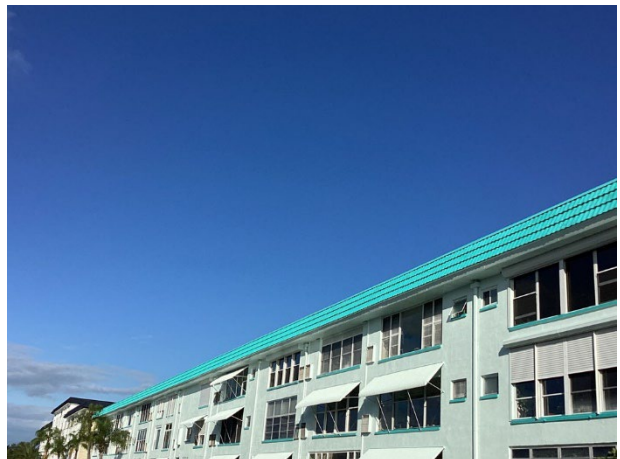
Condition: Good to fair overall with isolated damage evident from our visual inspection from the ground.

Metal mansard roof

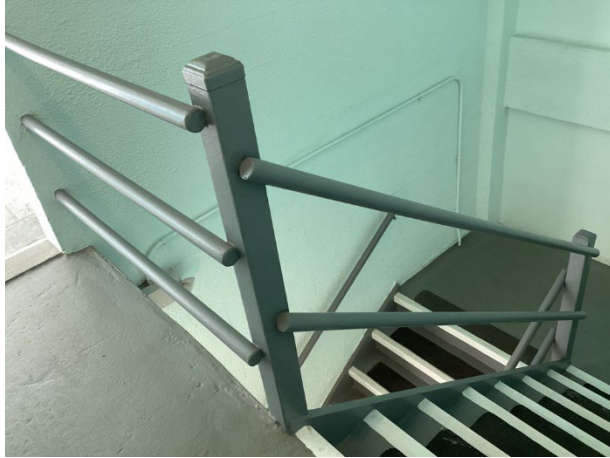
Condition: Good to fair overall with isolated damage evident.

Staircase overview

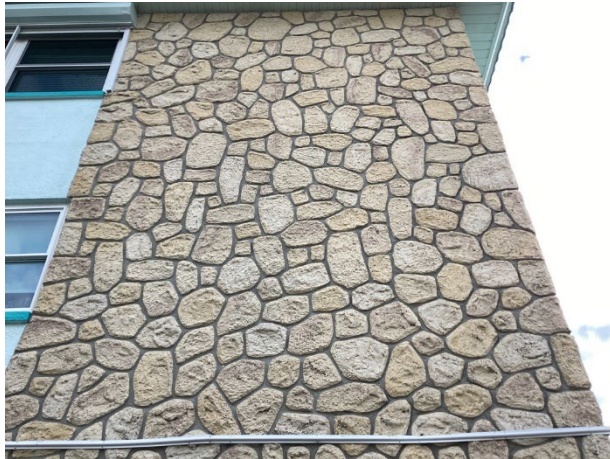
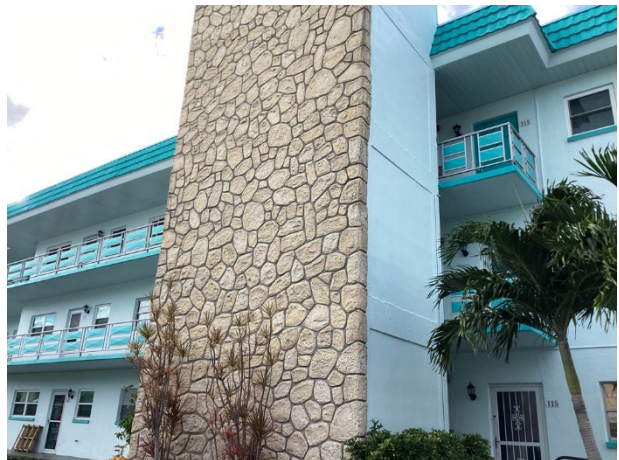
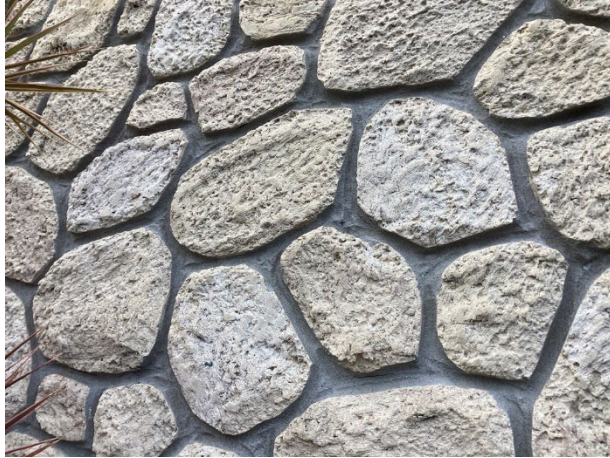
- No reported history of recent water infiltration
- Repairs and partial replacements have been conducted during previous projects
- Efflorescence is not visible
- Masonry exhibits minor cracks
- No spalled masonry is evident
- No mortar deterioration is evident

Masonry wall overview

- Complete inspection of the masonry
- Repointing of up to ninety-eight percent (98%) of the masonry
- Replacement of up to two percent (2.0%) (The exact amount of area in need of replacement will be discretionary based on the actual future conditions and the desired appearance.)

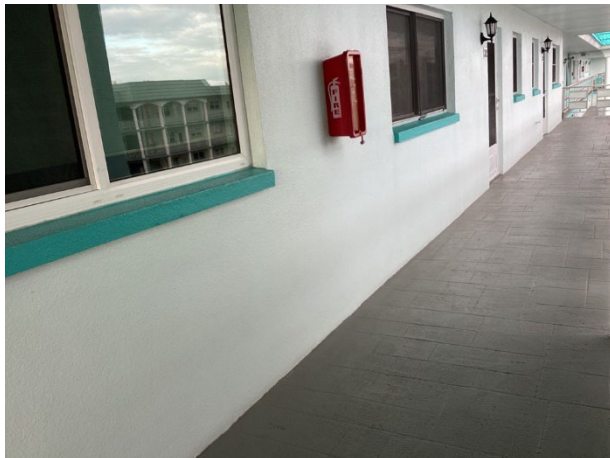
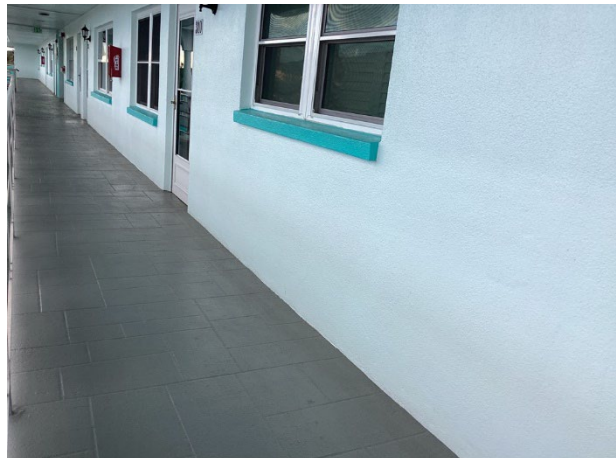
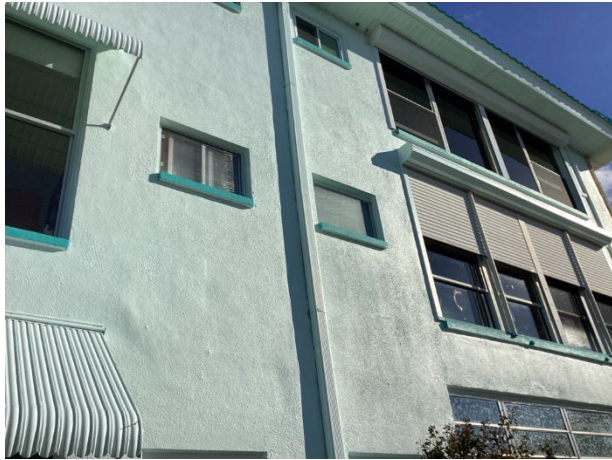
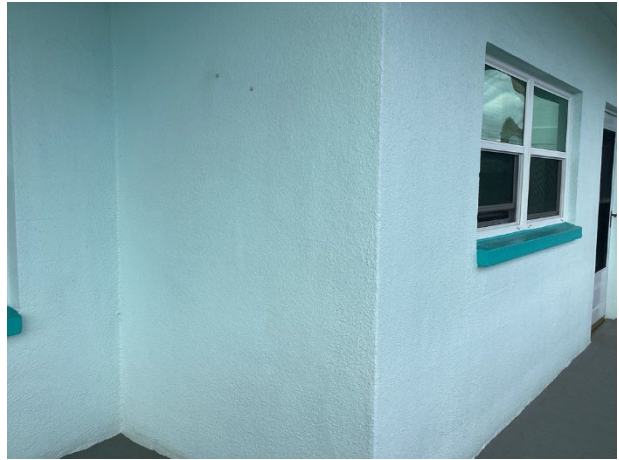
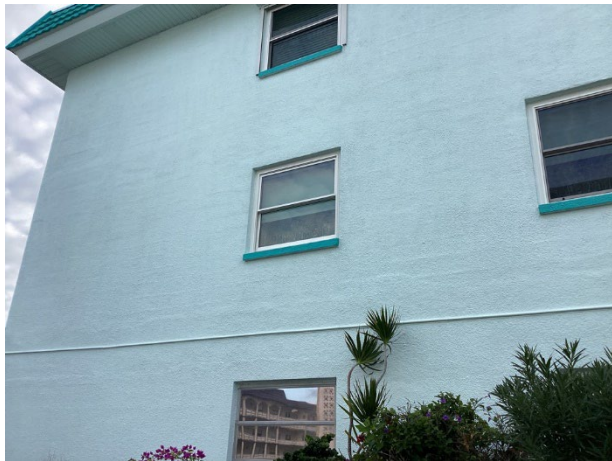
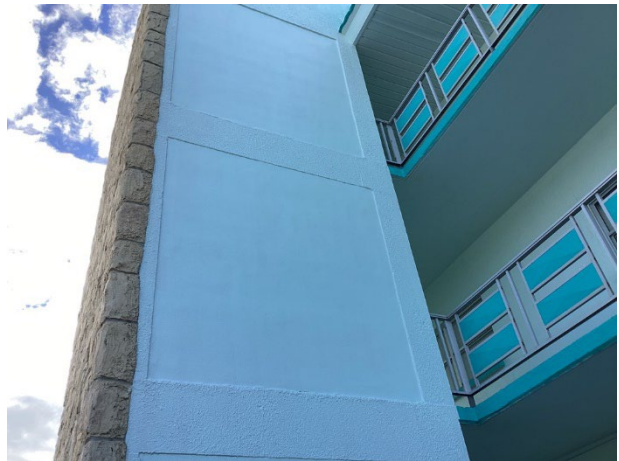
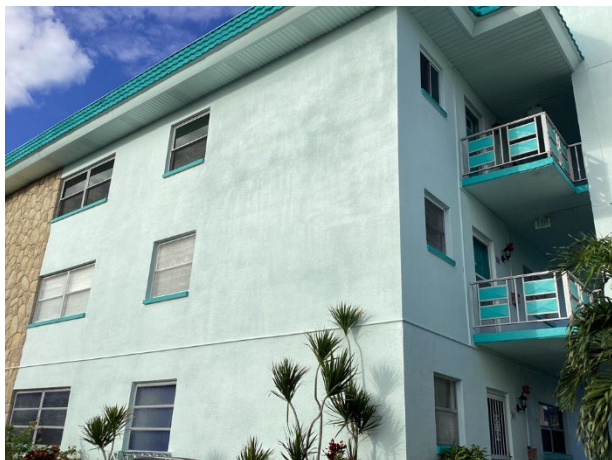
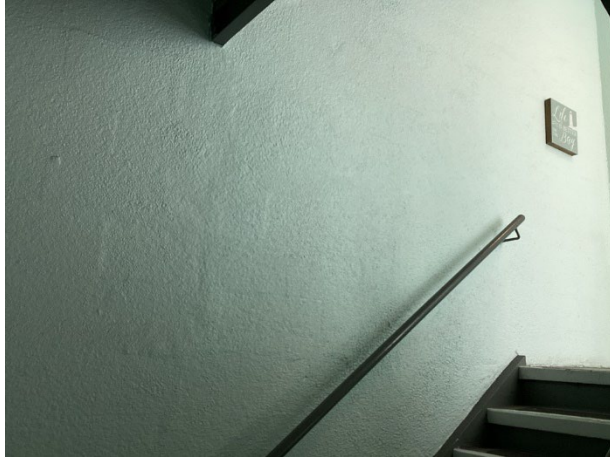
Condition: Good to fair overall with isolated spalls and evidence of water intrusion evident. We note the following:

- Isolated damage is evident
- Sealants are in good condition

- Complete inspection of the stucco
- Crack repairs as needed (Each paint product has the limited ability to cover and seal cracks but we recommend repair of all cracks which exceed the ability of the paint product to bridge.)
- Replacement of up to one percent (1%), of the stucco walls (The exact amount of area in need of replacement will be discretionary based on the actual future conditions and the desired appearance.)
- Replacement of up to thirty-three percent (33%) of the sealants in coordination with each paint finish application.
- Concrete restoration as needed (The exact amount of area in need of replacement will be discretionary based on the actual future conditions)

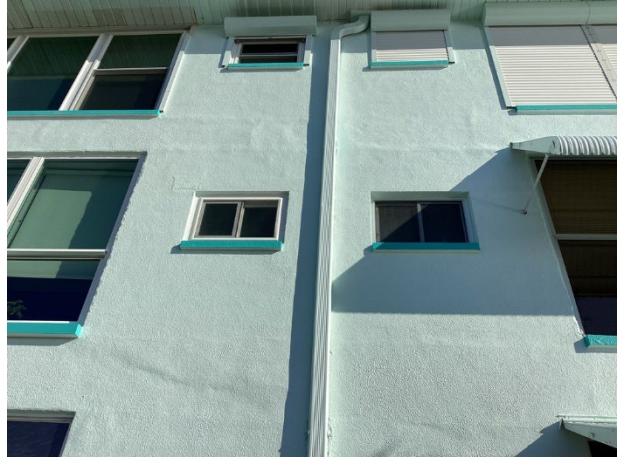
Stucco wall finishes with evidence of minor water intrusion

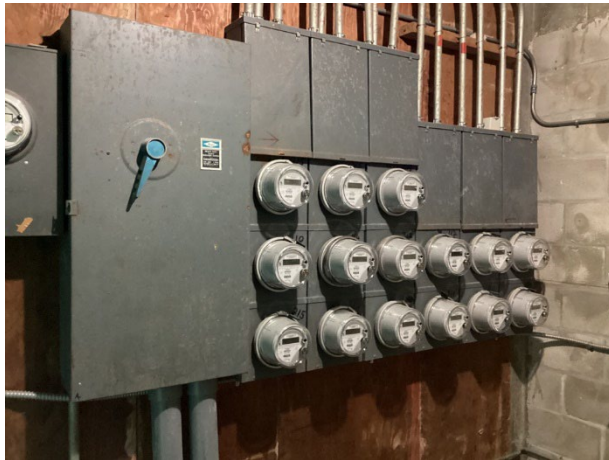
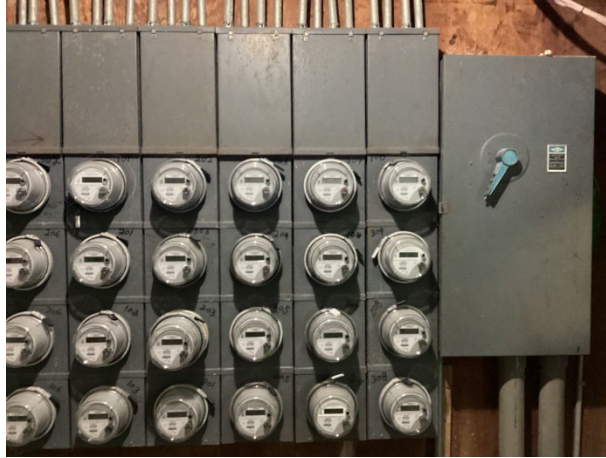
- No obvious combustible material storage was observed in electrical rooms. However, our inspection is not exhaustive and the Association should conduct periodic inspections of the electrical rooms to ensure compliance with 10.18.5 of NFPA 1.
- The electrical rooms we observed were properly labeled.
- No obvious exposed wires were observed during our site inspection. However, our inspection is not exhaustive and the Association should conduct periodic inspections of the electrical rooms to ensure no unsafe conditions develop.
- Rust at electrical panels was present. This indicates a presence of moisture or water which can result in unsafe conditions. The Association should further explore the cause of the rust and repair or replace the rusted panels.
- No apparent water was observed in or near the electrical rooms.

Electrical system components

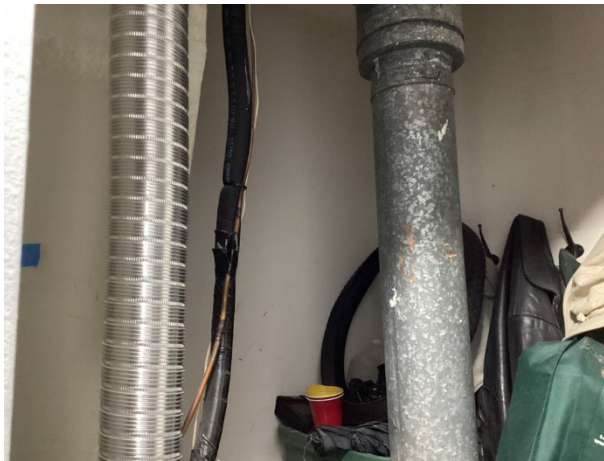
- Domestic Water – Reported satisfactory without operational deficiencies
 - Isolated history of domestic hot water leaks is reported
 - Isolated history of domestic cold water leaks is reported
 - The Association does not report a history of low water pressure.
- Sanitary Waste Disposal and Vent – Reported satisfactory without operational deficiencies
 - Isolated history of waste or vent pipe leaks is reported

Galvanized steel pipe seen inside the units

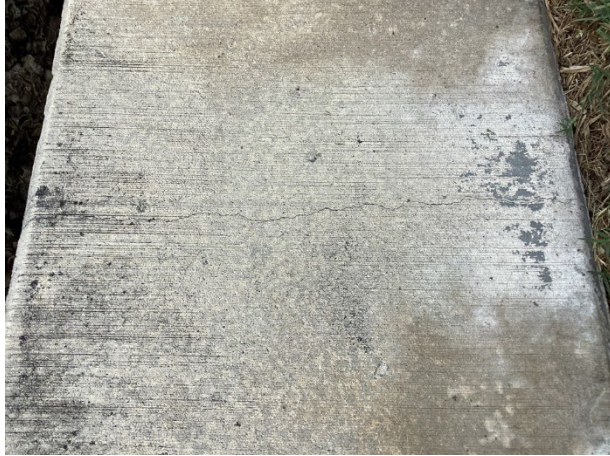
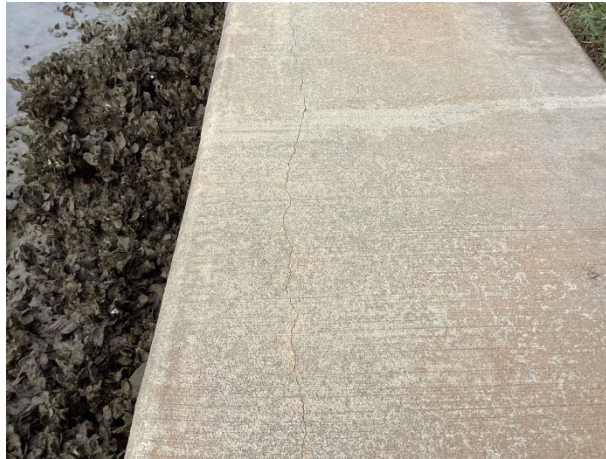
Wall cap with cracks

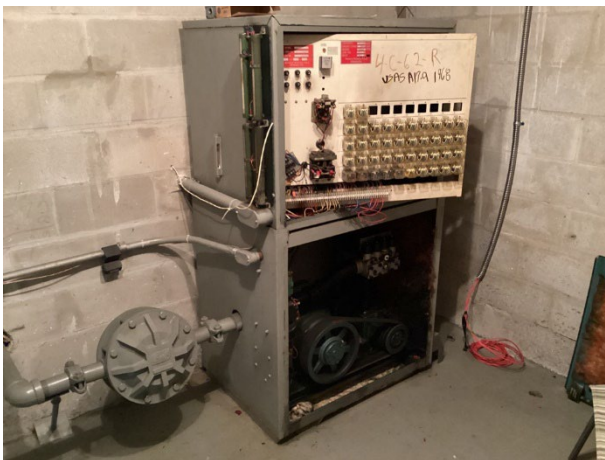
Condition: Reported unsatisfactory and service interruptions are reportedly frequent

Hydraulic elevator equipment

History: We are informed that the hydraulic elevator is budgeted to be completely modernized in 2023. Modernization includes replacement of the cab finishes, pump, controls and cylinder. We have shown the remaining budgeted payments to made from Reserves in 2023.

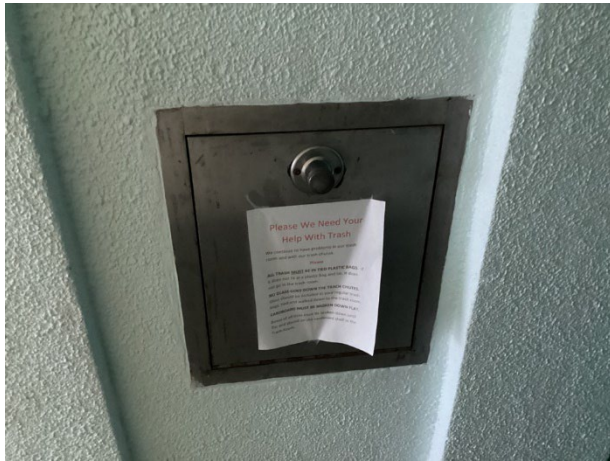
Condition: Reported satisfactory without operational deficiencies. We note rust evident.

Trash chute door
