Groton Condominium Association, Town Shores of Gulfport # 204, Inc.

October 17, 2023 • Gulfport, FL

**STRUCTURAL INTEGRITY
RESERVE STUDY**

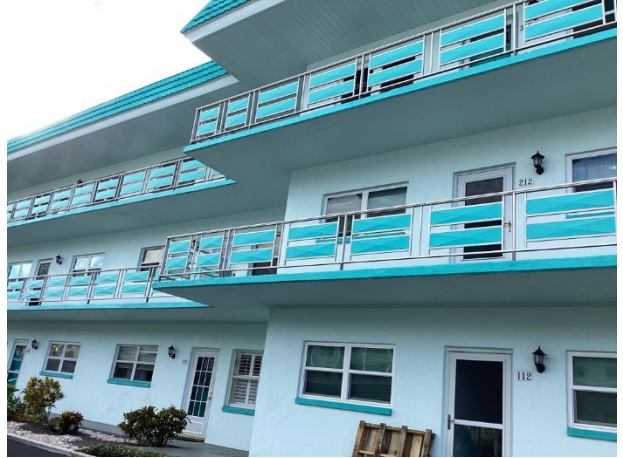
Breezeways overview

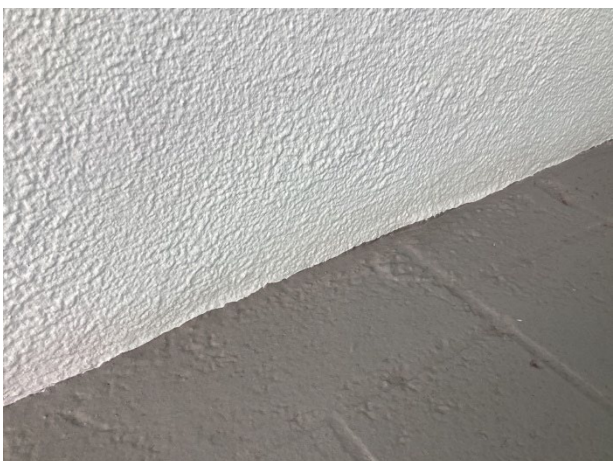
- Sealants are in good condition
- The coatings are in good to fair condition
- Minor concrete coating deterioration is evident
- Isolated concrete cracks are evident
- Isolated concrete spalls are evident
- Exposed reinforcements were not observed at the time of our inspection

Breezeway sealant

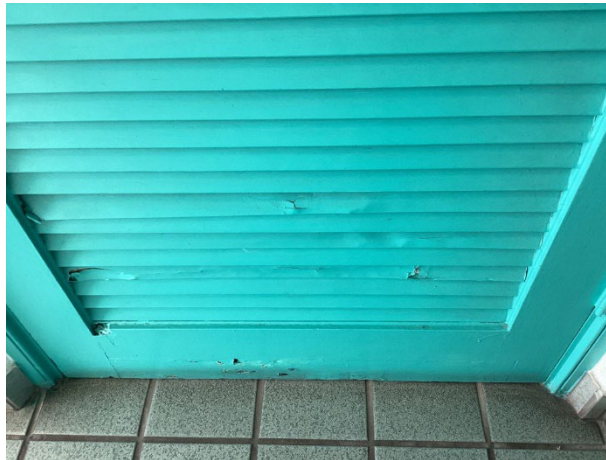
Rust and peeled finishes at the common area door

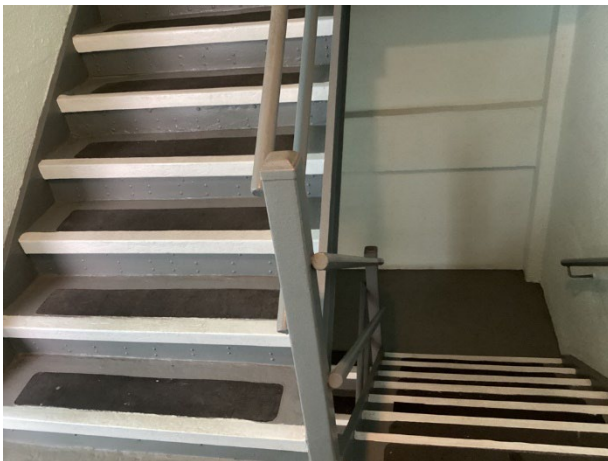
Condition: Good to fair overall with isolated damage evident.

Staircase overview

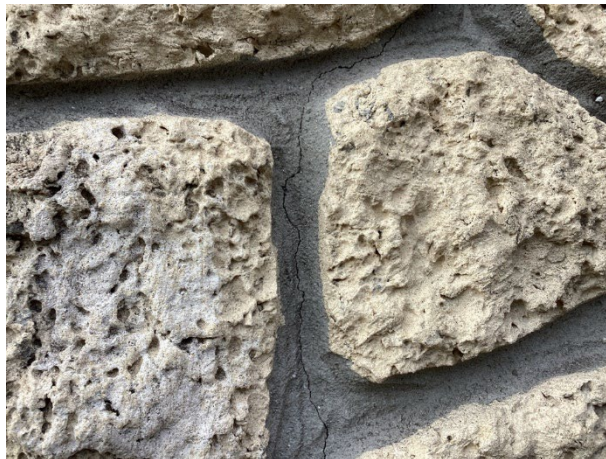
- No reported history of recent water infiltration
- Repairs and partial replacements have been conducted during previous projects
- Efflorescence is not visible
- Masonry exhibits minor cracks
- No spalled masonry is evident
- No mortar deterioration is evident

Mortar cracks

Repointing is a process of raking and cutting out defective mortar to a depth of not less than $\frac{1}{2}$ inch nor more than $\frac{3}{4}$ inch and replacing it with new mortar. Face grouting is the process of placing mortar over top of the existing mortar. We advise against face grouting because the existing, often deteriorated mortar does not provide a solid base for the new mortar. New mortar spalls at face grouted areas will likely occur. One purpose of a mortar joint is to protect the masonry by relieving stresses within the wall caused by expansion, contraction, moisture migration and settlement. Repointed mortar joints are more effective if the mortar is softer and more permeable than the masonry units, and no harder or less permeable than the existing mortar. The masonry contractor should address these issues within the proposed scope of work.

- Complete inspection of the masonry
- Repointing of up to ninety-eight percent (98%) of the masonry
- Replacement of up to two percent (2.0%) (The exact amount of area in need of replacement will be discretionary based on the actual future conditions and the desired appearance.)

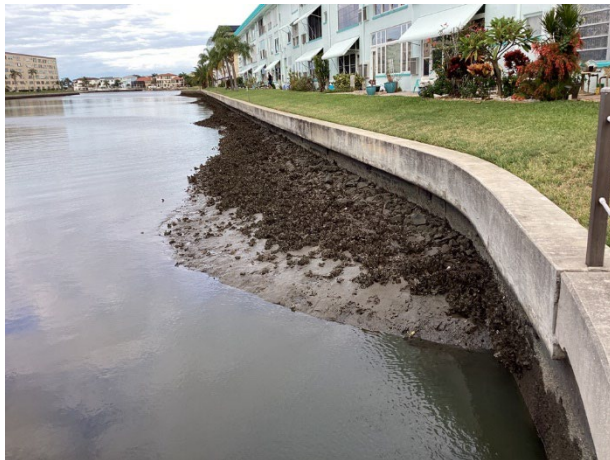
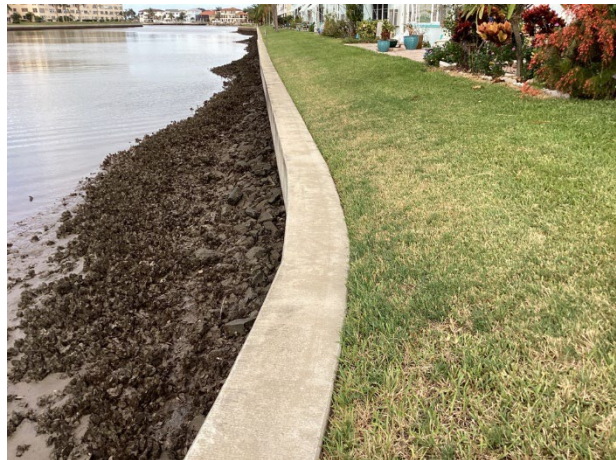
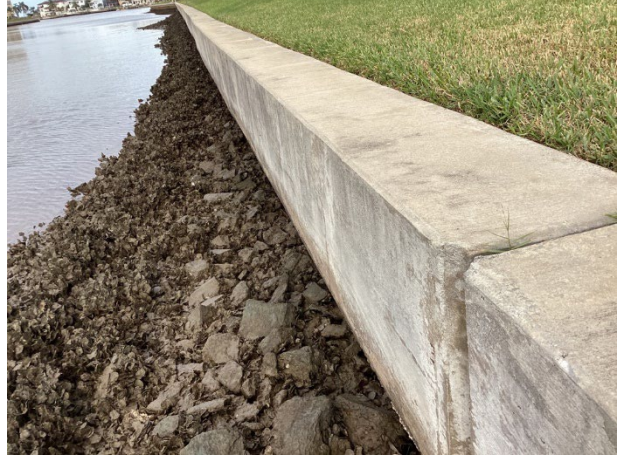
Conditions: Good to fair overall with concrete cracks evident.

Concrete bulkhead

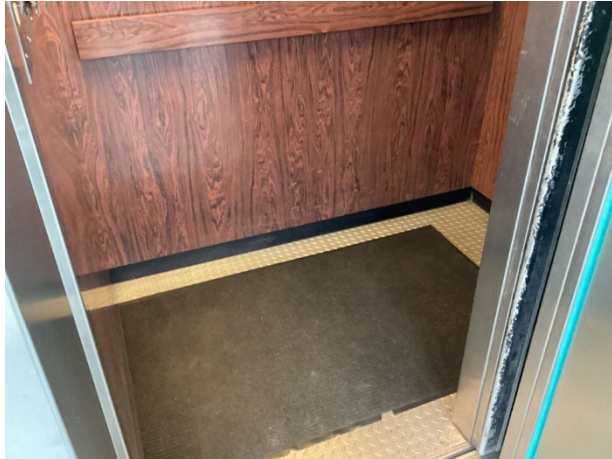
Condition: Fair to poor overall with damage evident.

Elevator cab finishes

History: We are informed that the elevator cab finishes are budgeted to be replaced in 2023. This near-term expenditure is reflected in Line Item 3.320.

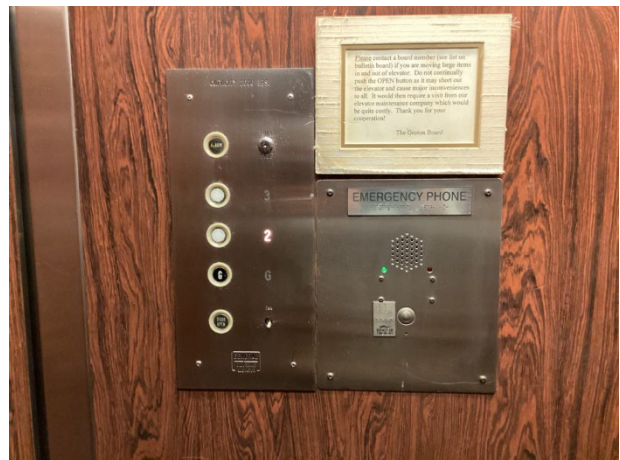
Condition: Reported unsatisfactory and service interruptions are reportedly frequent

Hydraulic elevator call buttons

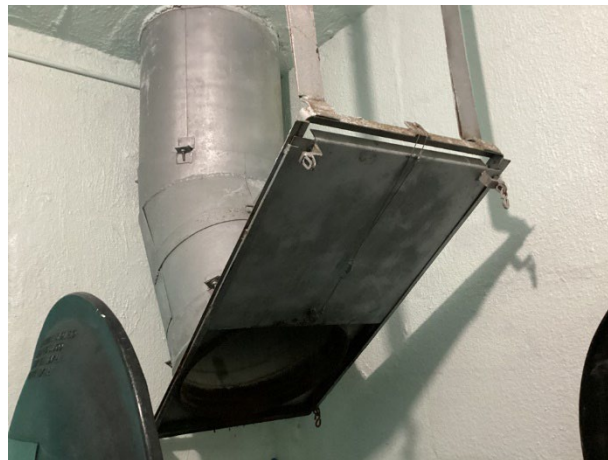
Trash chute

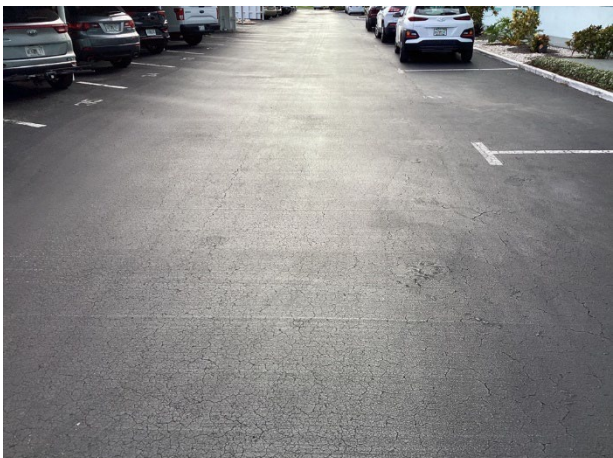
Condition: Fair overall with frequent cracks, potholes, patch repairs, raveling, and deterioration evident.

Pavement overview

The manner of repaving is either a mill and overlay or total replacement. A mill and overlay is a method of repaving where cracked, worn and failed pavement is mechanically removed or milled until sound pavement is found. A new layer of asphalt is overlaid atop the remaining base course of pavement. Total replacement includes the removal of all existing asphalt down to the base course of aggregate and native soil followed by the application of two or more new lifts of asphalt. We recommend mill and overlayment on asphalt pavement that exhibits normal deterioration and wear. We recommend total replacement of asphalt pavement that exhibits severe deterioration, inadequate drainage, pavement that has been overlaid multiple times in the past or where the configuration makes overlayment not possible. Based on the apparent visual condition and configuration of the asphalt pavement, we recommend the mill and overlay method of repaving at Groton Condominium Association.

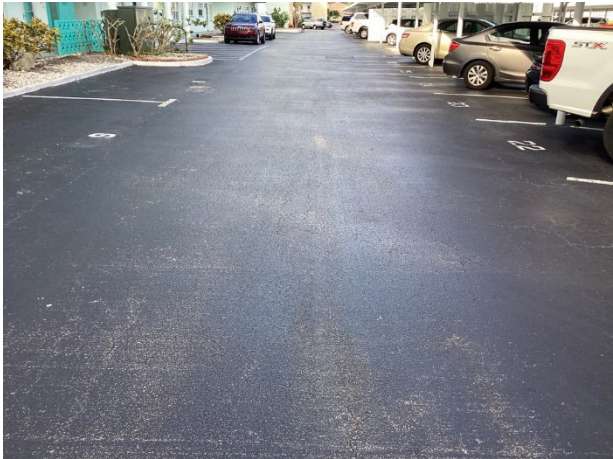
Pavement overview
